Arch Ave. (in grass at Dow) - Spot Replacement - MH1643 to 1643

Pipe Graphic Report of PLR 3664

for Hillsdale

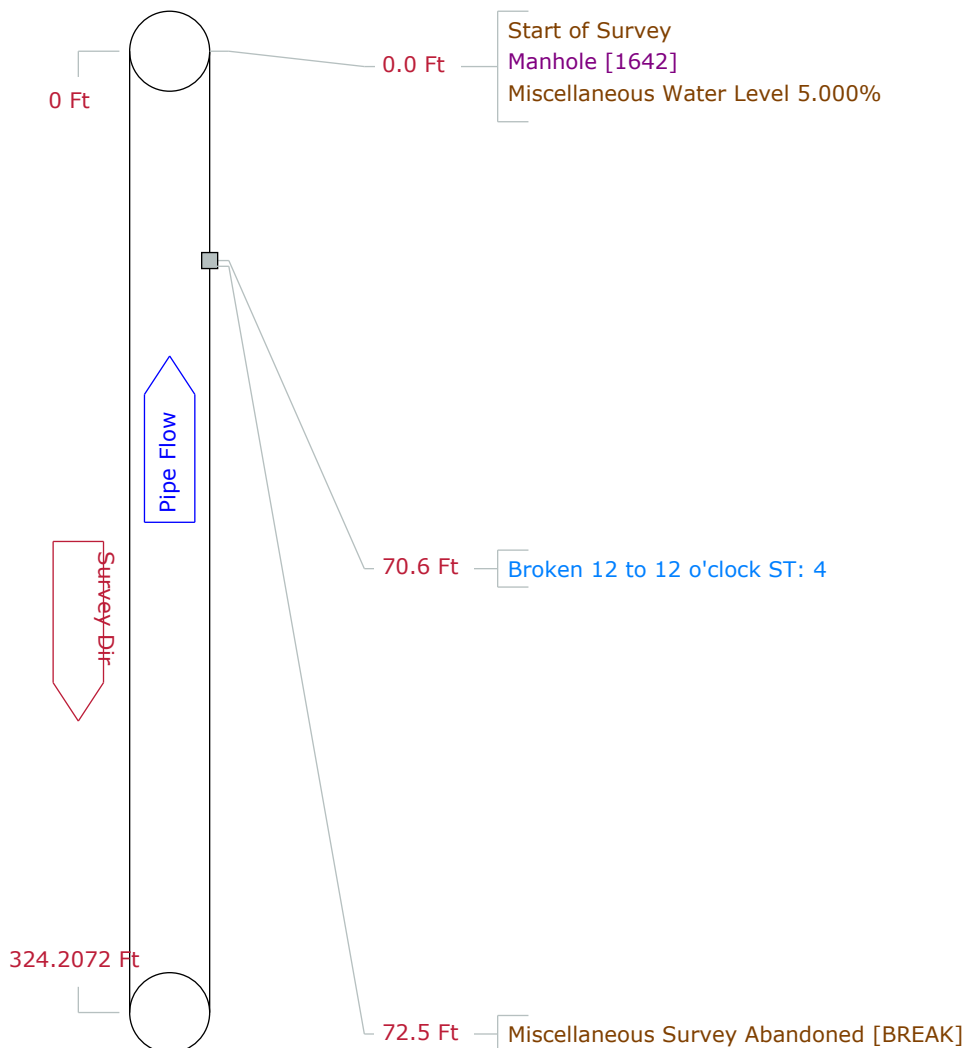
Count	Video	CD	Code	Val1	Val2	%	Jnt	Fr	To	ImRef	Remarks
0.0			ST Start of Survey								
0.0			AMH Manhole								1642
0.0			MWL Miscellaneous Water Level			5.000					
70.6			B Broken				J	12	12		
72.5			MSA Miscellaneous Survey Abandoned								BREAK

Scores	Structural:	Pipe Rating 4	Pipe Ratings Index 4	Quick Rating 4100
	O&M:	Pipe Rating 0	Pipe Ratings Index 0	Quick Rating 0000
	Overall	Pipe Rating 4	Pipe Ratings Index 4.0	Quick Rating 4100

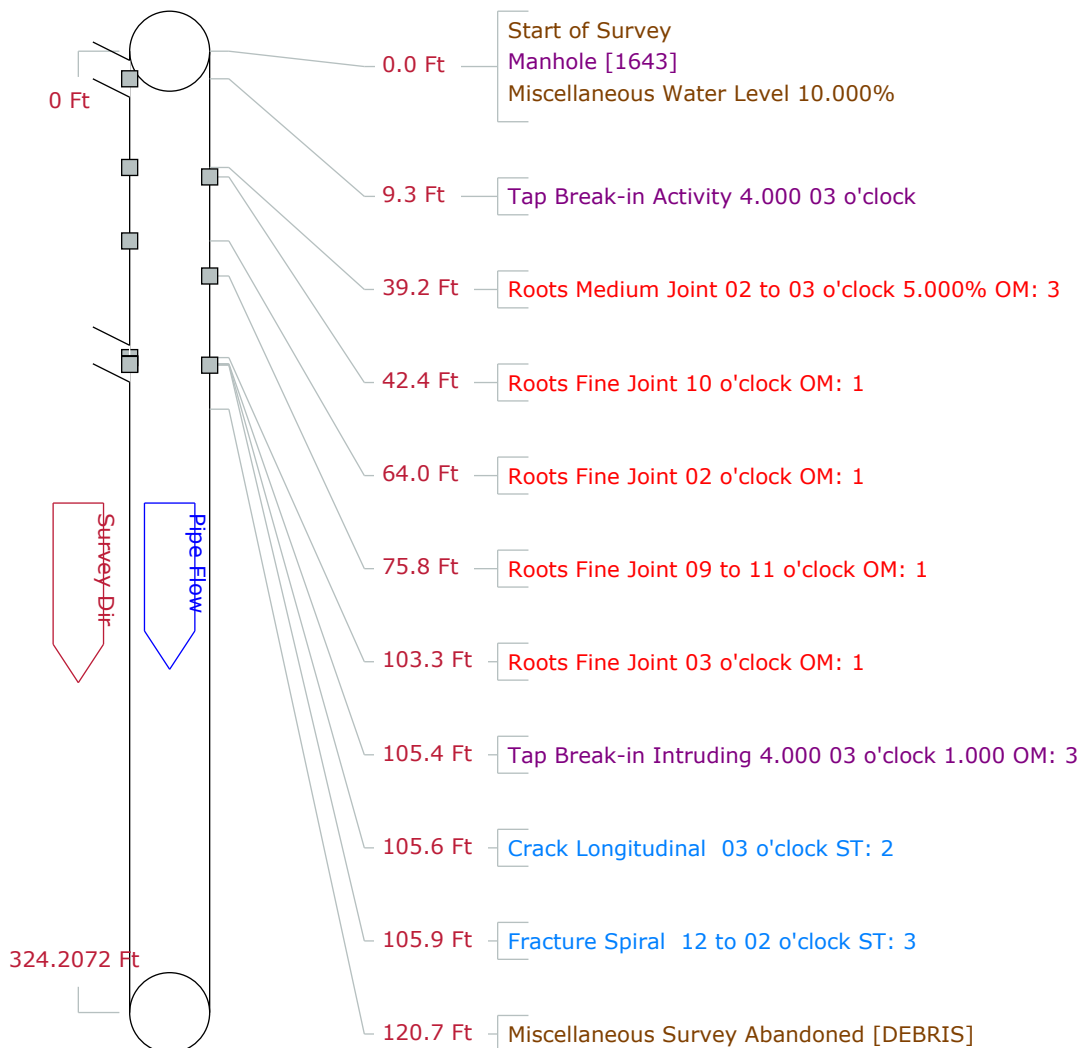
Count Video	CD Code	Val1	Val2	%	Jnt	Fr	To	ImRef	Remarks
0.0	ST								Start of Survey
0.0	AMH								Manhole 1643
0.0	MWL			10.000					Miscellaneous Water Level
9.3	TBA	4.000				03			Tap Break-in Activity
39.2	RMJ			5.000	J	02	03		Roots Medium Joint
42.4	RFJ				J	10			Roots Fine Joint
64.0	RFJ				J	02			Roots Fine Joint
75.8	RFJ				J	09	11		Roots Fine Joint
103.3	RFJ				J	03			Roots Fine Joint
105.4	TBI	4.000	1.000			03			Tap Break-in Intruding
105.6	CL				J	03			Crack Longitudinal
105.9	FS				J	12	02		Fracture Spiral
120.7	MSA								Miscellaneous Survey Abandoned

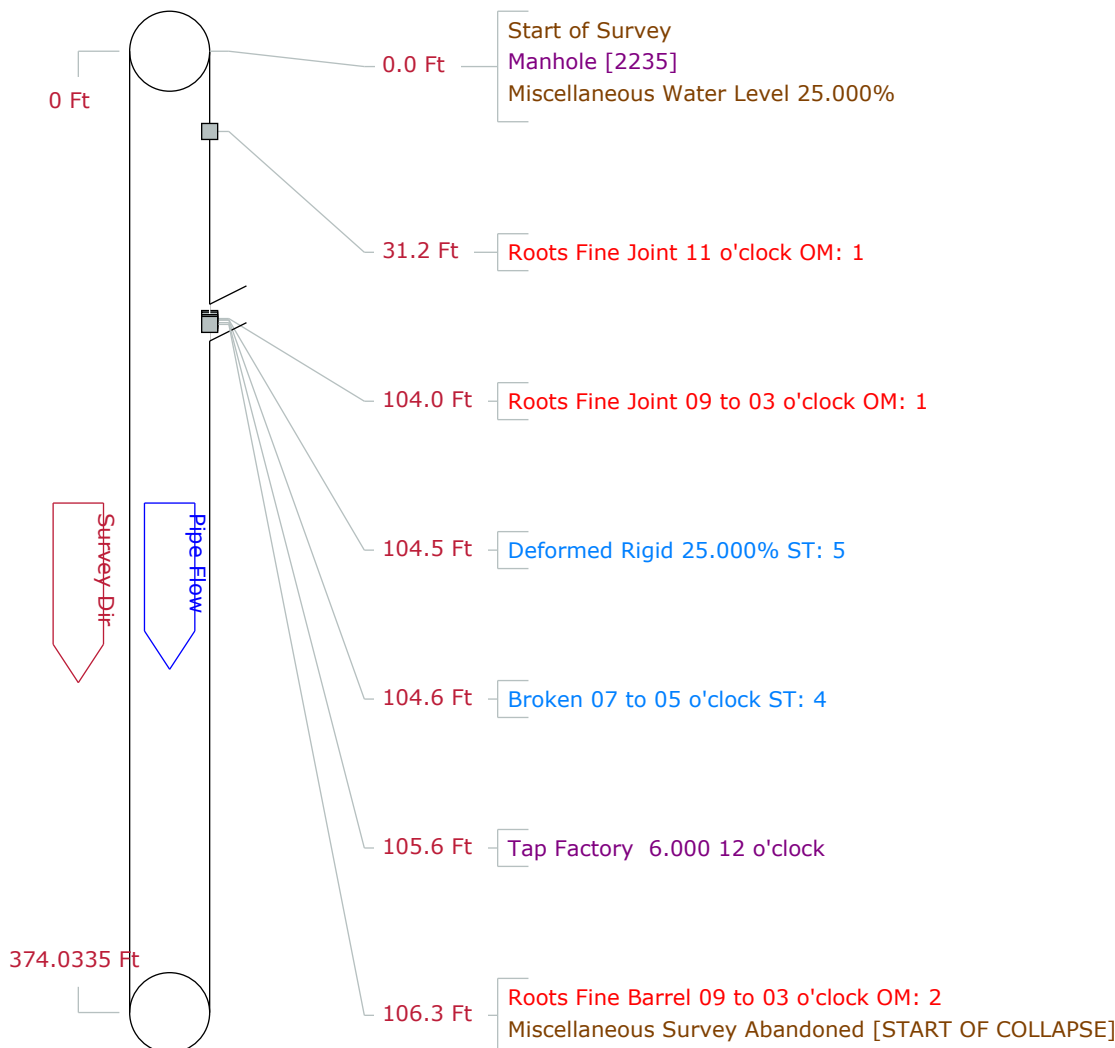
Count Video	CD Code	Val1	Val2	%	Jnt	Fr	To	ImRef	Remarks
0.0	ST	Start of Survey							
0.0	AMH	Manhole							2235
0.0	MWL	Miscellaneous Water Level		25.000					
31.2	RFJ	Roots Fine Joint			J	11			
104.0	RFJ	Roots Fine Joint			J	09	03		
104.5	DR	Deformed Rigid		25.000					
104.6	B	Broken			J	07	05		
105.6	TF	Tap Factory	6.000			12			
106.3	RFB	Roots Fine Barrel				09	03		
106.3	MSA	Miscellaneous Survey Abandoned							START OF COLLAPSE

Buena Vista Dr. - Spot Replacement - MH2235 to 2234

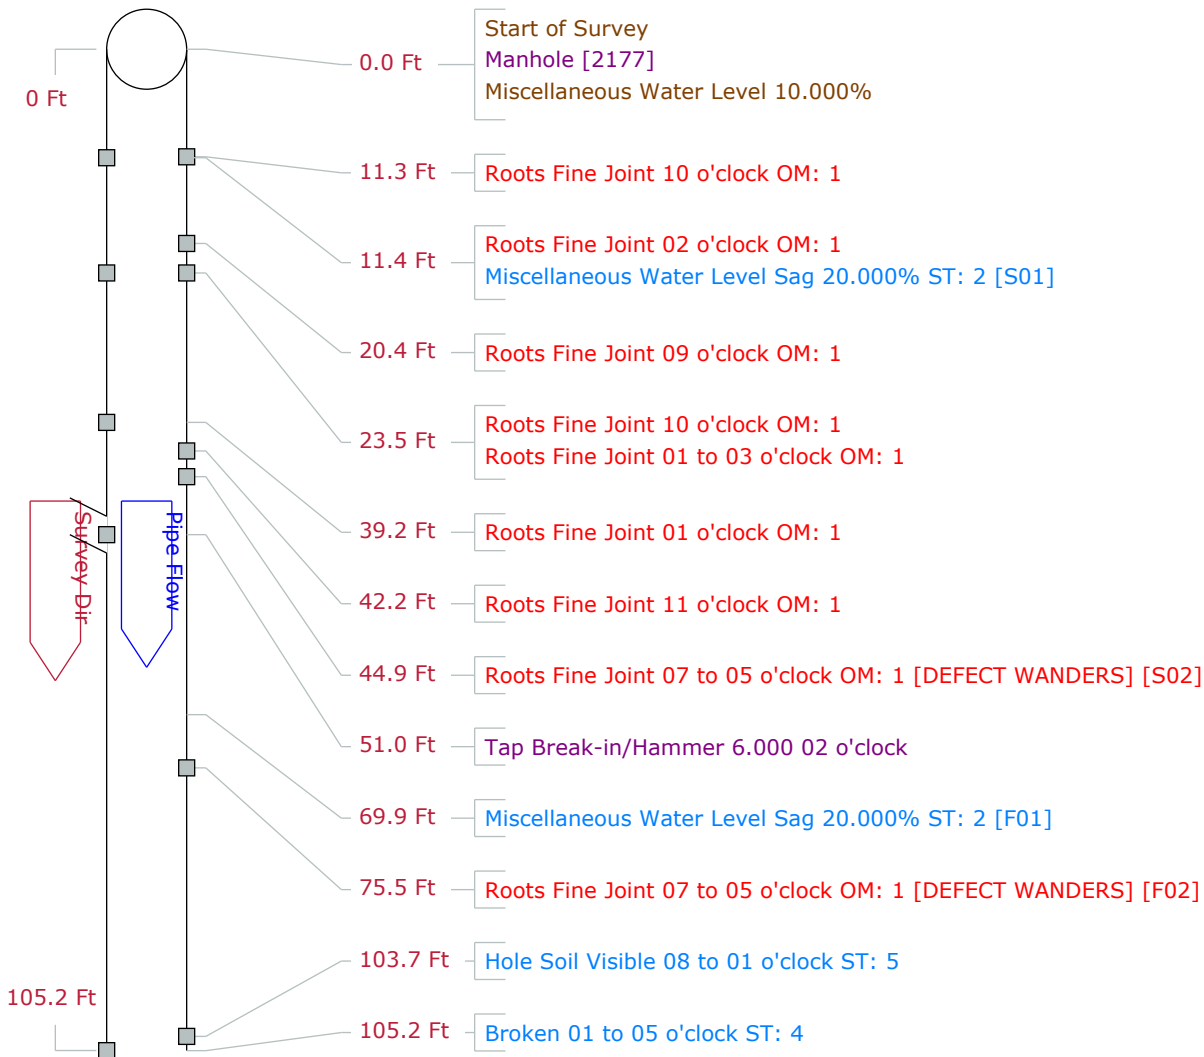
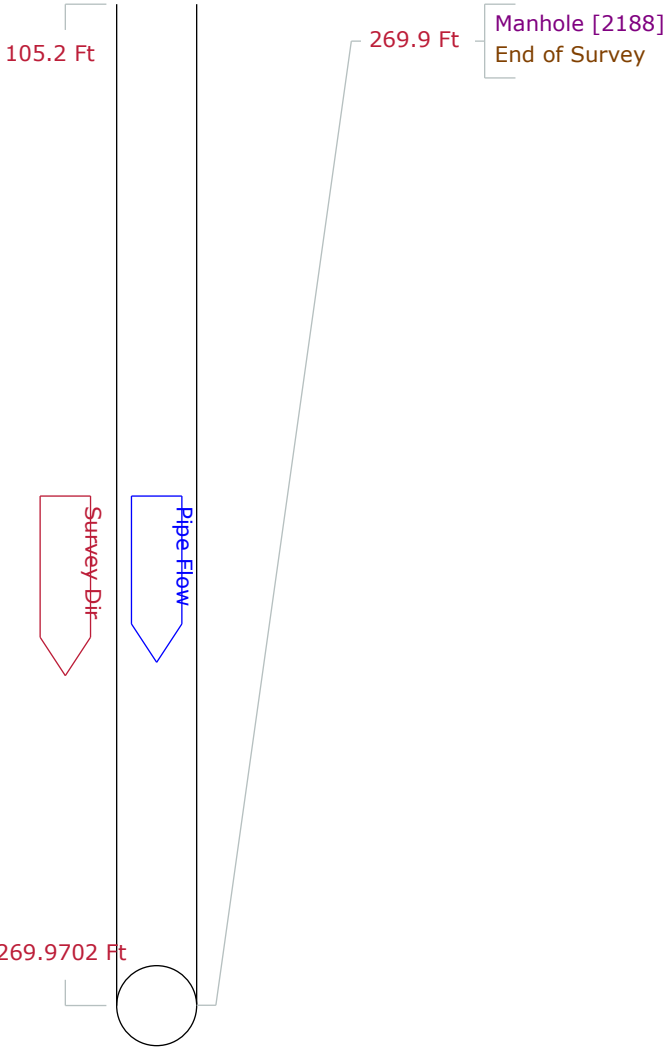
Count	Video	CD Code	Val1	Val2	%	Jnt	Fr	To	ImRef	Remarks
0.0		ST	Start of Survey							
0.0		AMH	Manhole							2177
0.0		MWL	Miscellaneous Water Level		10.000					
11.3		RFJ	Roots Fine Joint			J	10			
11.4		RFJ	Roots Fine Joint			J	02			
11.4		S01	MWLS Miscellaneous Water Level Sag		20.000					
20.4		RFJ	Roots Fine Joint			J	09			
23.5		RFJ	Roots Fine Joint			J	10			
23.5		RFJ	Roots Fine Joint			J	01	03		
39.2		RFJ	Roots Fine Joint			J	01			
42.2		RFJ	Roots Fine Joint			J	11			
44.9		S02	RFJ Roots Fine Joint			J	07	05		DEFECT WANDERS
51.0		TB	Tap Break-in/Hammer	6.000			02			
69.9		F01	MWLS Miscellaneous Water Level Sag		20.000					
75.5		F02	RFJ Roots Fine Joint			J	07	05		DEFECT WANDERS
103.7		HSV	Hole Soil Visible				08	01		
105.2		B	Broken				01	05		
269.9		AMH	Manhole							2188
269.9		FH	End of Survey

Division St. - Spot Replacement - MH2177 to 2188

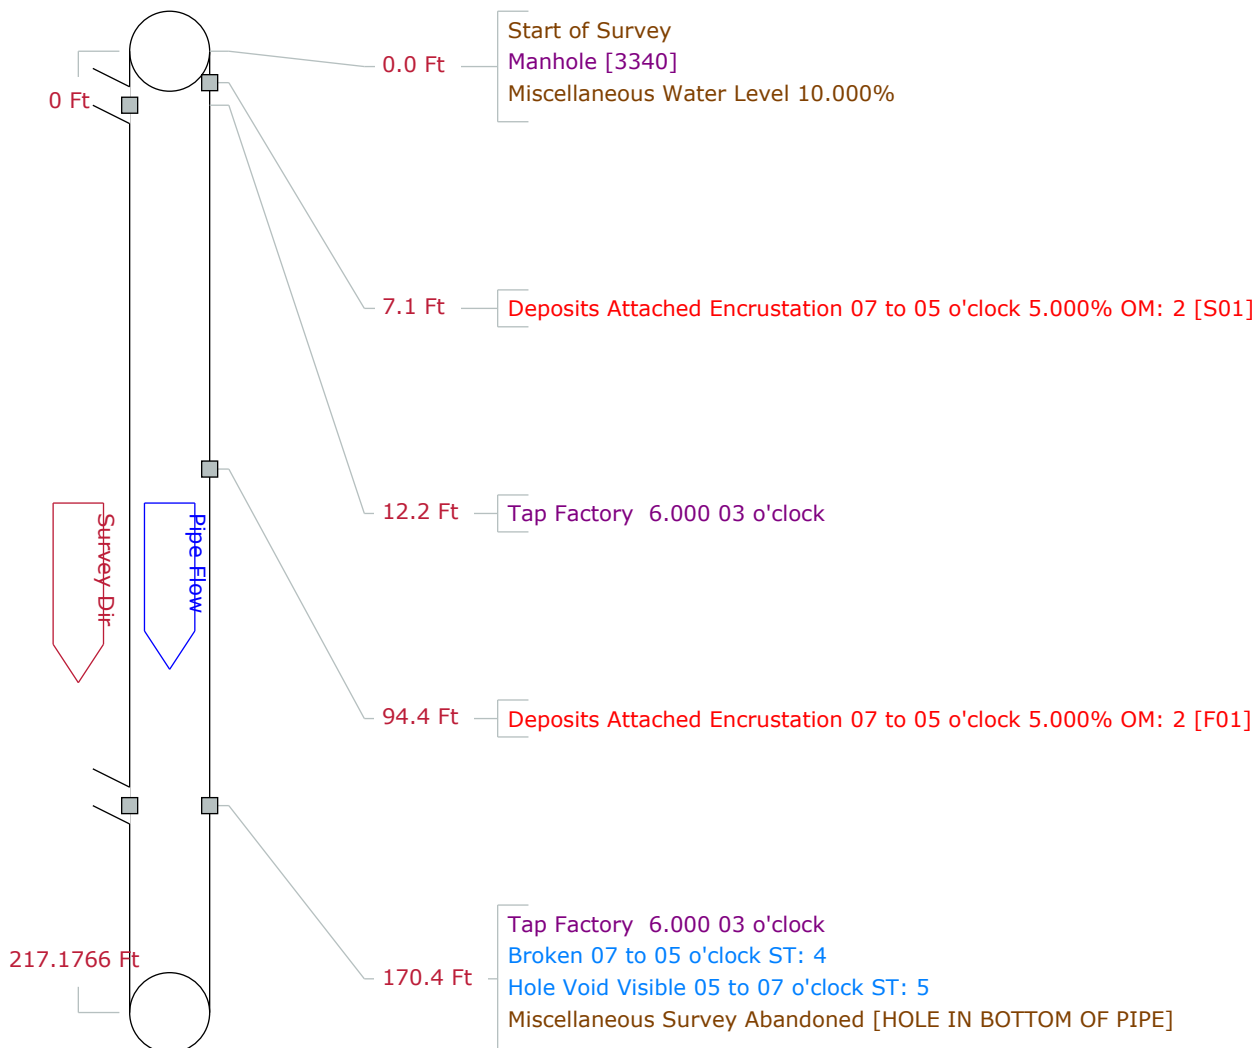
Count Video	CD Code	Val1	Val2	%	Jnt	Fr	To	ImRef	Remarks
0.0	ST	Start of Survey							
0.0	AMH	Manhole							3340
0.0	MWL	Miscellaneous Water Level		10.000					
7.1	S01	DAE	Deposits Attached Encrustation	5.000	J	07	05		
12.2	TF	Tap Factory	6.000			03			
94.4	F01	DAE	Deposits Attached Encrustation	5.000	J	07	05		
170.4	TF	Tap Factory	6.000			03			
170.4	B	Broken			J	07	05		
170.4	HVV	Hole Void Visible			J	05	07		
170.4	MSA	Miscellaneous Survey Abandoned							HOLE IN BOTTOM OF PIPE

Heathcliff (at Bacon) - Spot Replacement - MH3340 to 3455

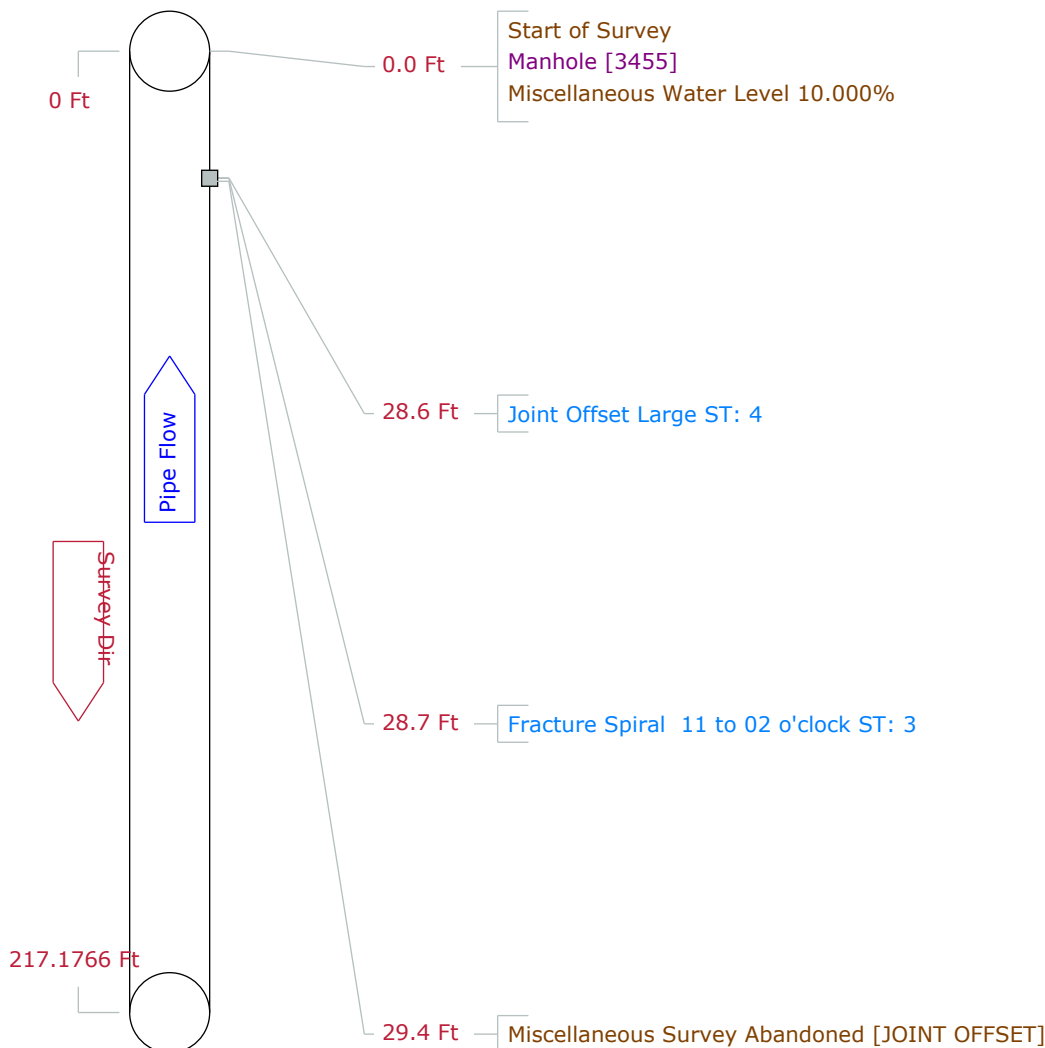
Count	Video	CD	Code	Val1	Val2	%	Jnt	Fr	To	ImRef	Remarks
0.0			ST Start of Survey								
0.0			AMH Manhole								3455
0.0			MWL Miscellaneous Water Level			10.000					
28.6			JOL Joint Offset Large								
28.7			FS Fracture Spiral				J	11	02		
29.4			MSA Miscellaneous Survey Abandoned								JOINT OFFSET

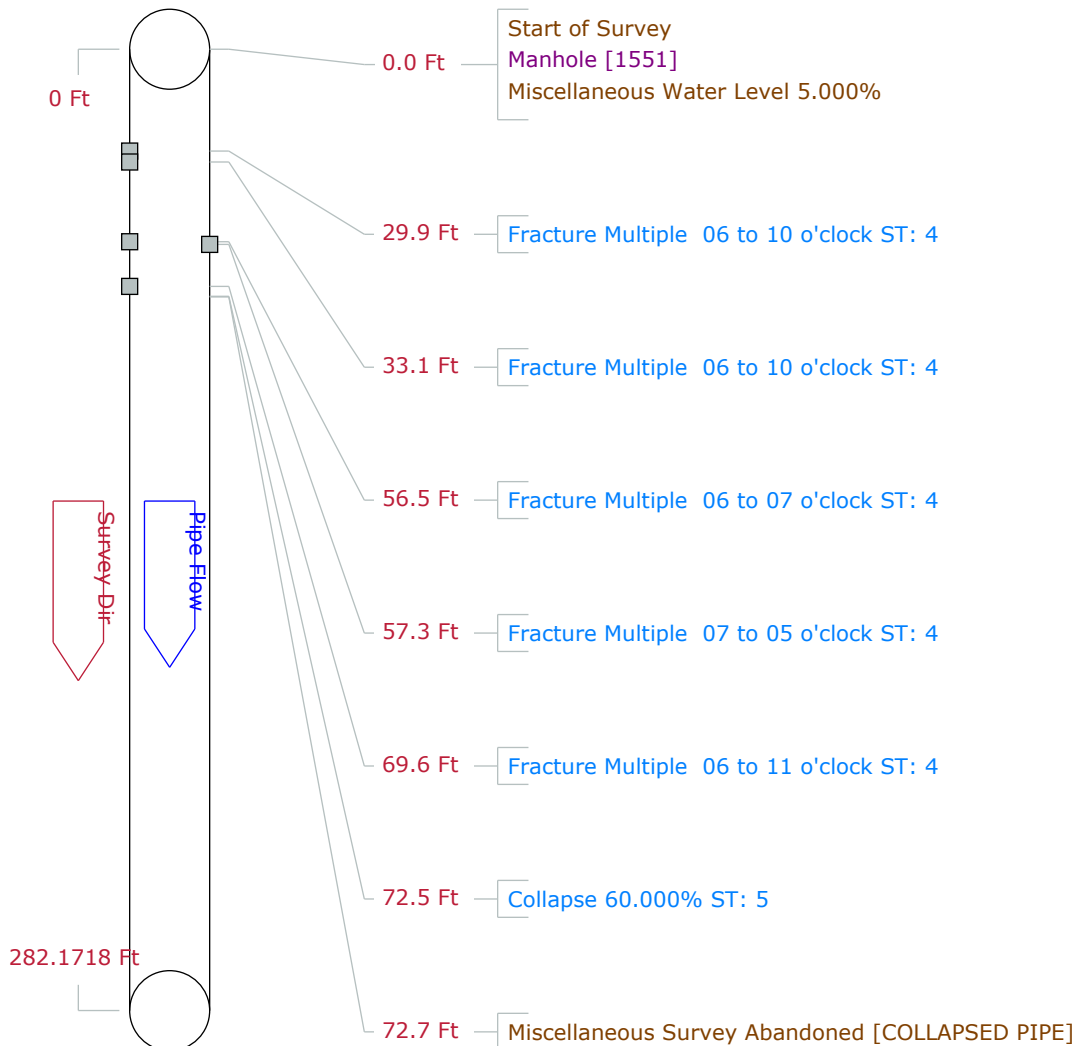
Count Video	CD Code	Val1	Val2	%	Jnt	Fr	To	ImRef	Remarks
0.0	ST								Start of Survey
0.0	AMH								1551
0.0	MWL			5.000					Miscellaneous Water Level
29.9	FM				J	06	10		Fracture Multiple
33.1	FM				J	06	10		Fracture Multiple
56.5	FM				J	06	07		Fracture Multiple
57.3	FM				J	07	05		Fracture Multiple
69.6	FM				J	06	11		Fracture Multiple
72.5	X			60.000					Collapse
72.7	MSA								Miscellaneous Survey Abandoned

Mechanic St - Full Replacement - MH1551 to 1552

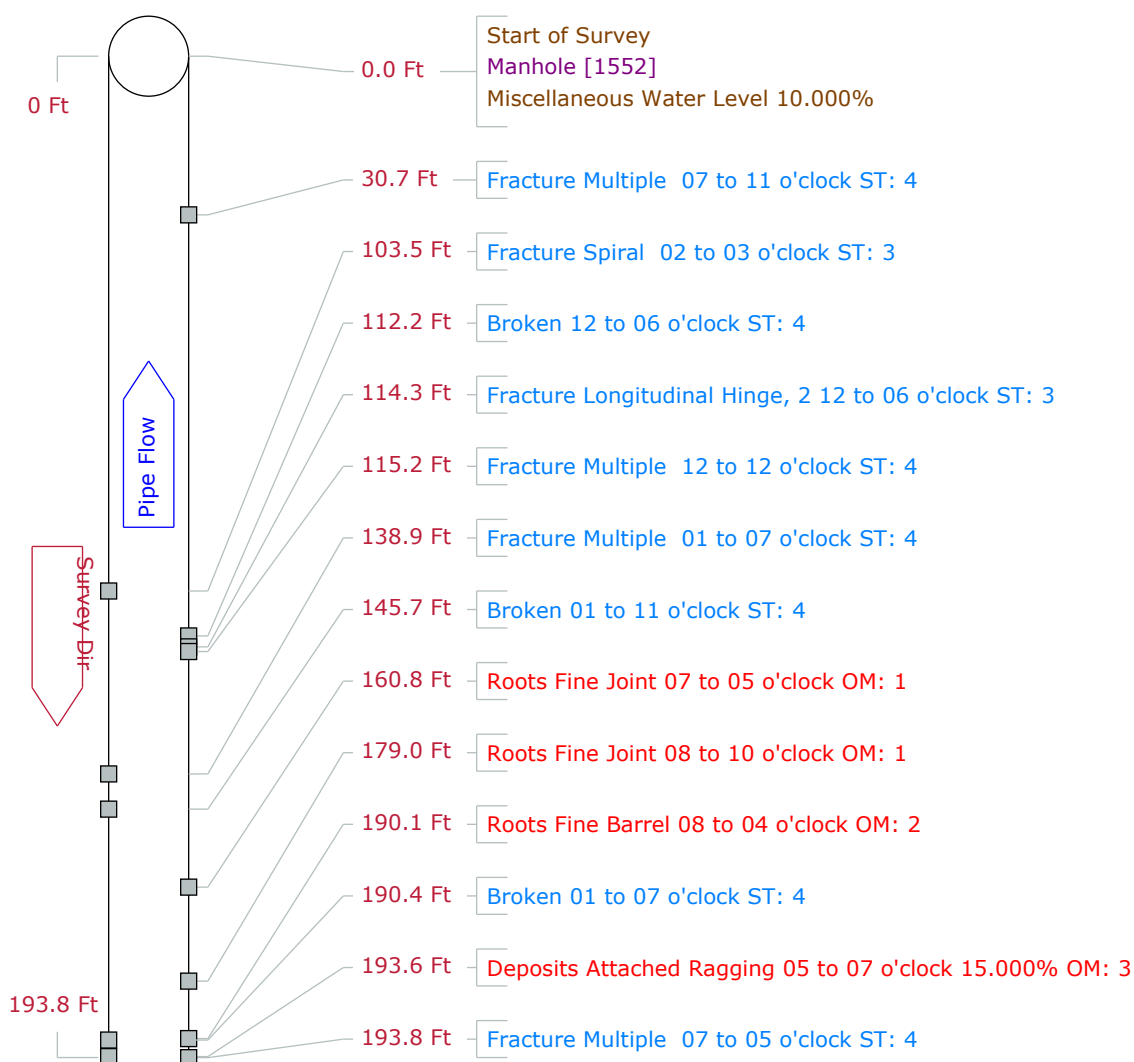
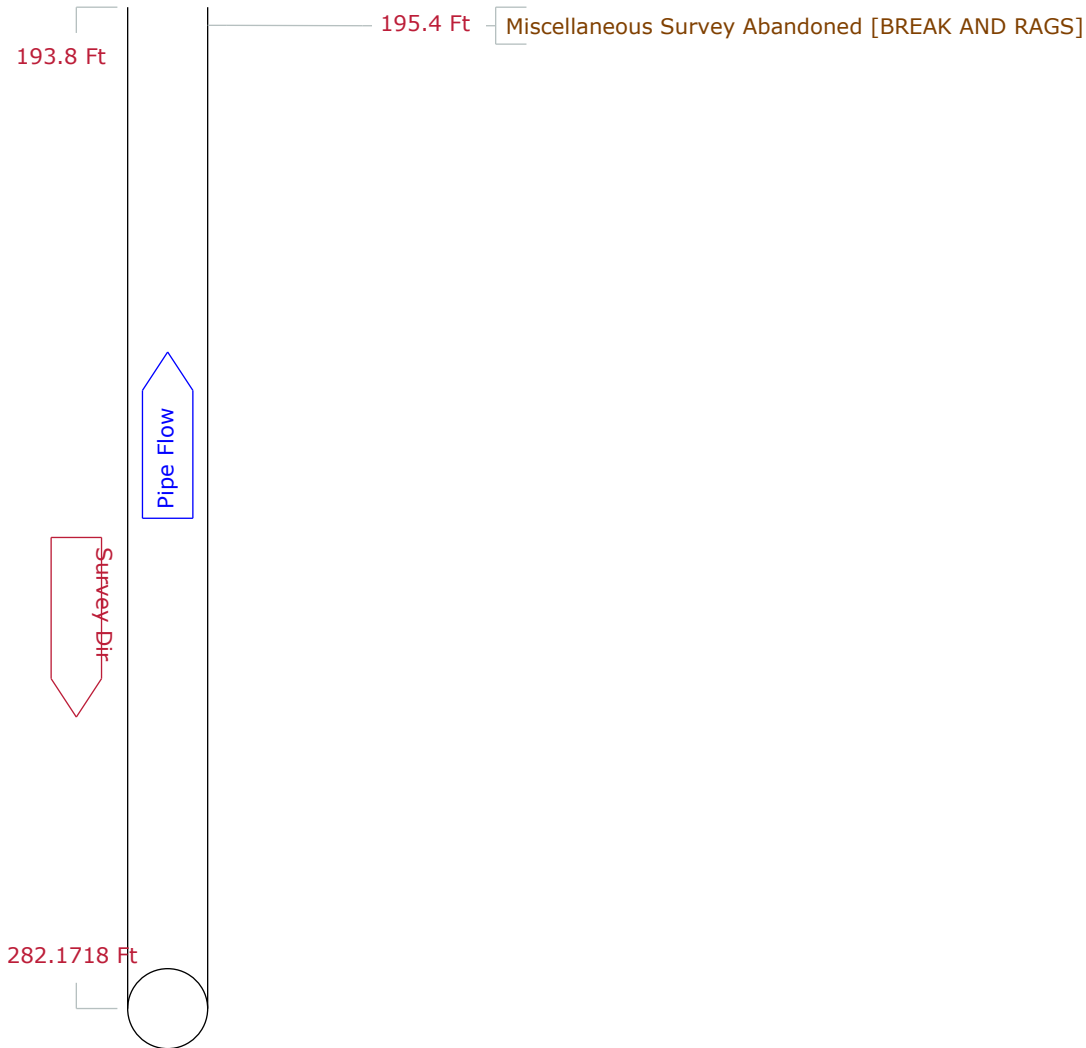
Count Video	CD Code	Val1	Val2	%	Jnt	Fr	To	ImRef	Remarks
0.0	ST								Start of Survey
0.0	AMH								Manhole 1552
0.0	MWL			10.000					Miscellaneous Water Level
30.7	FM				J	07	11		Fracture Multiple
103.5	FS				J	02	03		Fracture Spiral
112.2	B				J	12	06		Broken
114.3	FH2				J	12	06		Fracture Longitudinal Hinge, 2
115.2	FM				J	12	12		Fracture Multiple
138.9	FM				J	01	07		Fracture Multiple
145.7	B				J	01	11		Broken
160.8	RFJ				J	07	05		Roots Fine Joint
179.0	RFJ				J	08	10		Roots Fine Joint
190.1	RFB					08	04		Roots Fine Barrel
190.4	B				J	01	07		Broken
193.6	DAR			15.000		05	07		Deposits Attached Ragging
193.8	FM				J	07	05		Fracture Multiple
195.4	MSA								Miscellaneous Survey Abandoned

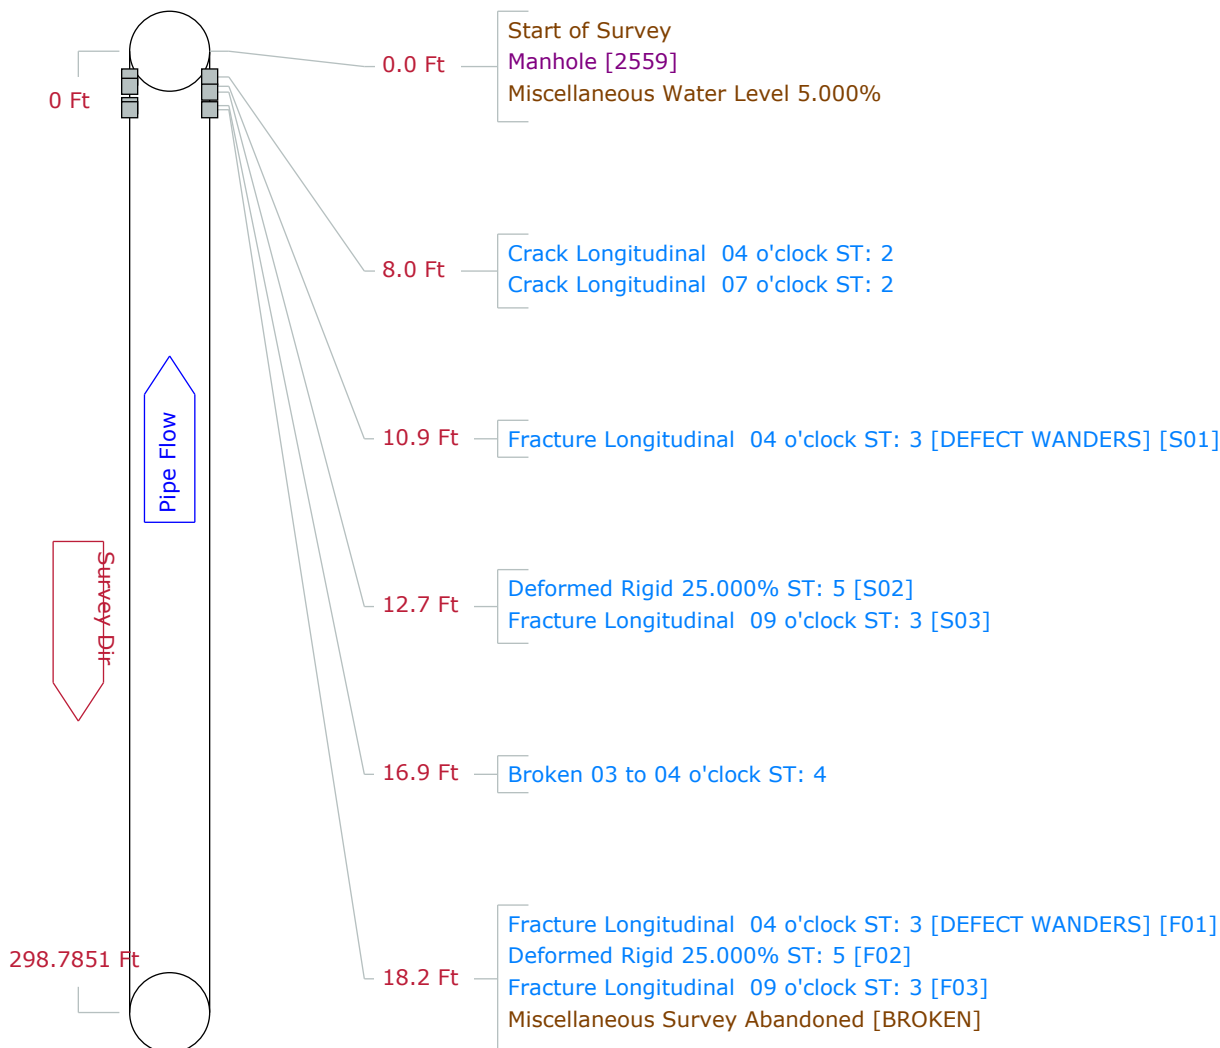
Count	Video	CD	Code	Val1	Val2	%	Jnt	Fr	To	Im	Ref	Remarks
0.0			ST Start of Survey									
0.0			AMH Manhole									2559
0.0			MWL Miscellaneous Water Level			5.000						
8.0			CL Crack Longitudinal				J	04				
8.0			CL Crack Longitudinal				J	07				
10.9		S01	FL Fracture Longitudinal					04				DEFECT WANDERS
12.7		S02	DR Deformed Rigid			25.000						
12.7		S03	FL Fracture Longitudinal					09				
16.9			B Broken					03	04			
18.2		F01	FL Fracture Longitudinal					04				DEFECT WANDERS
18.2		F02	DR Deformed Rigid			25.000						
18.2		F03	FL Fracture Longitudinal					09				
18.2			MSA Miscellaneous Survey Abandoned									BROKEN

W. St. Joe St. - Full Replacement - MH2559 to 2560

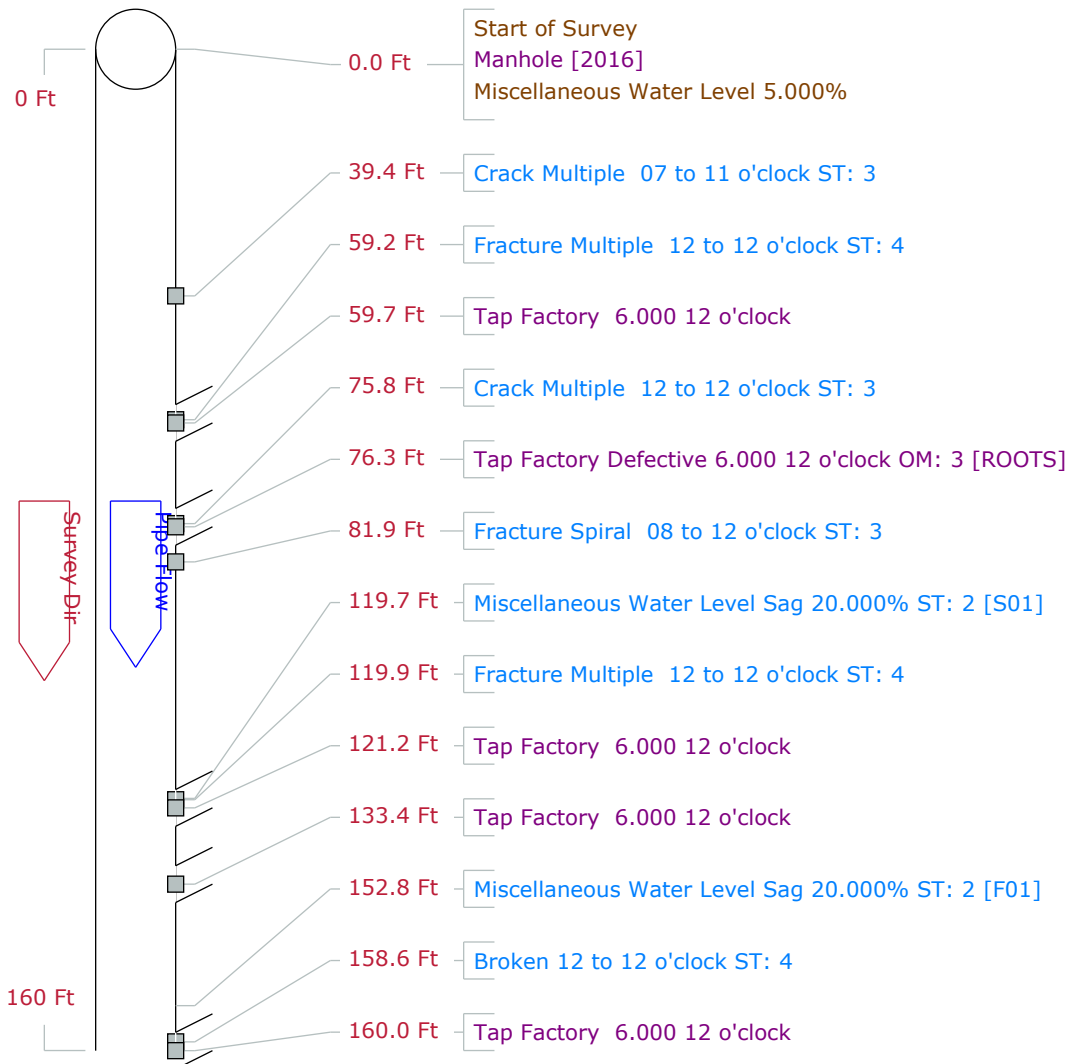
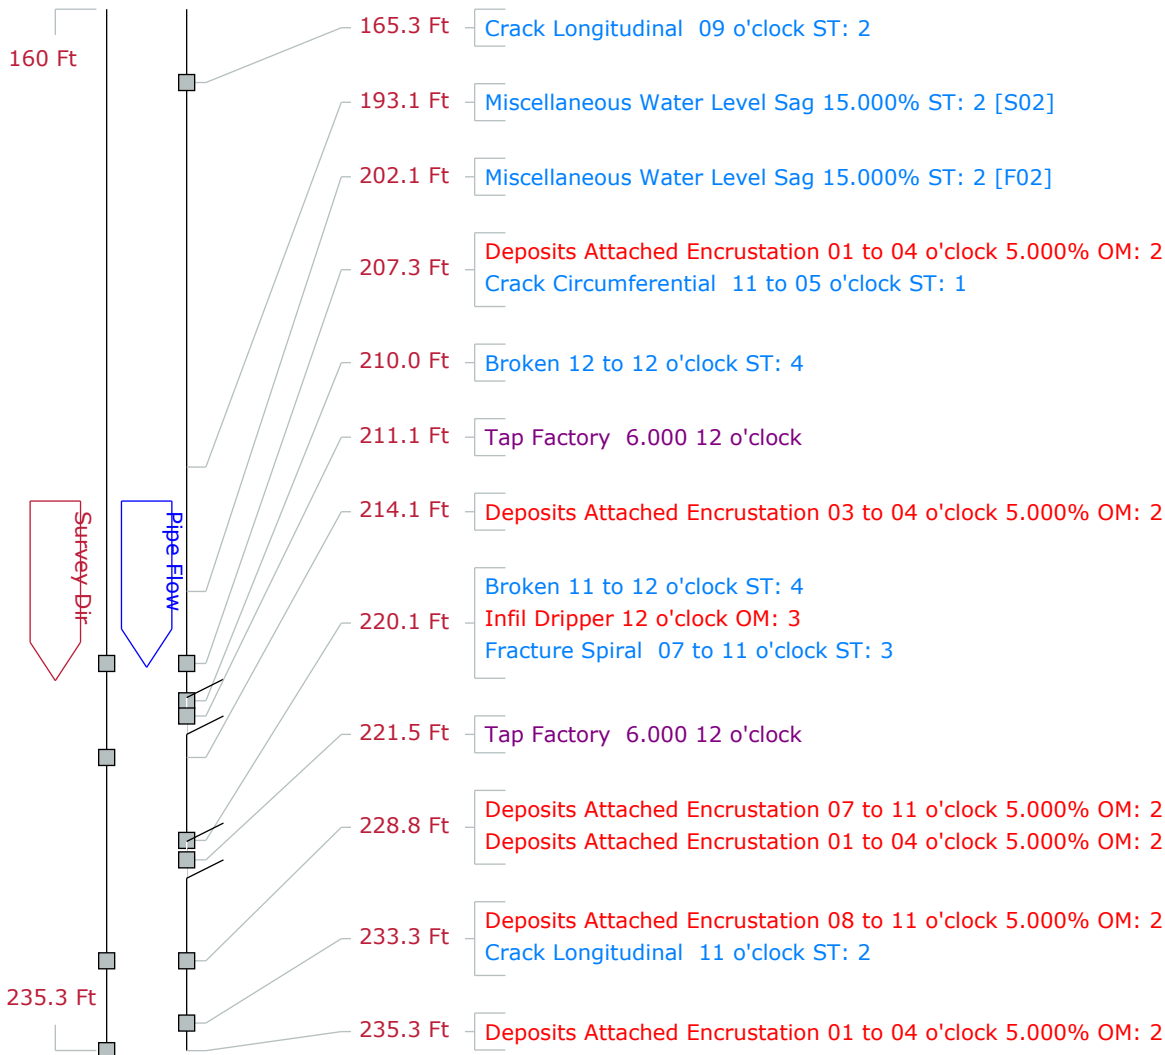
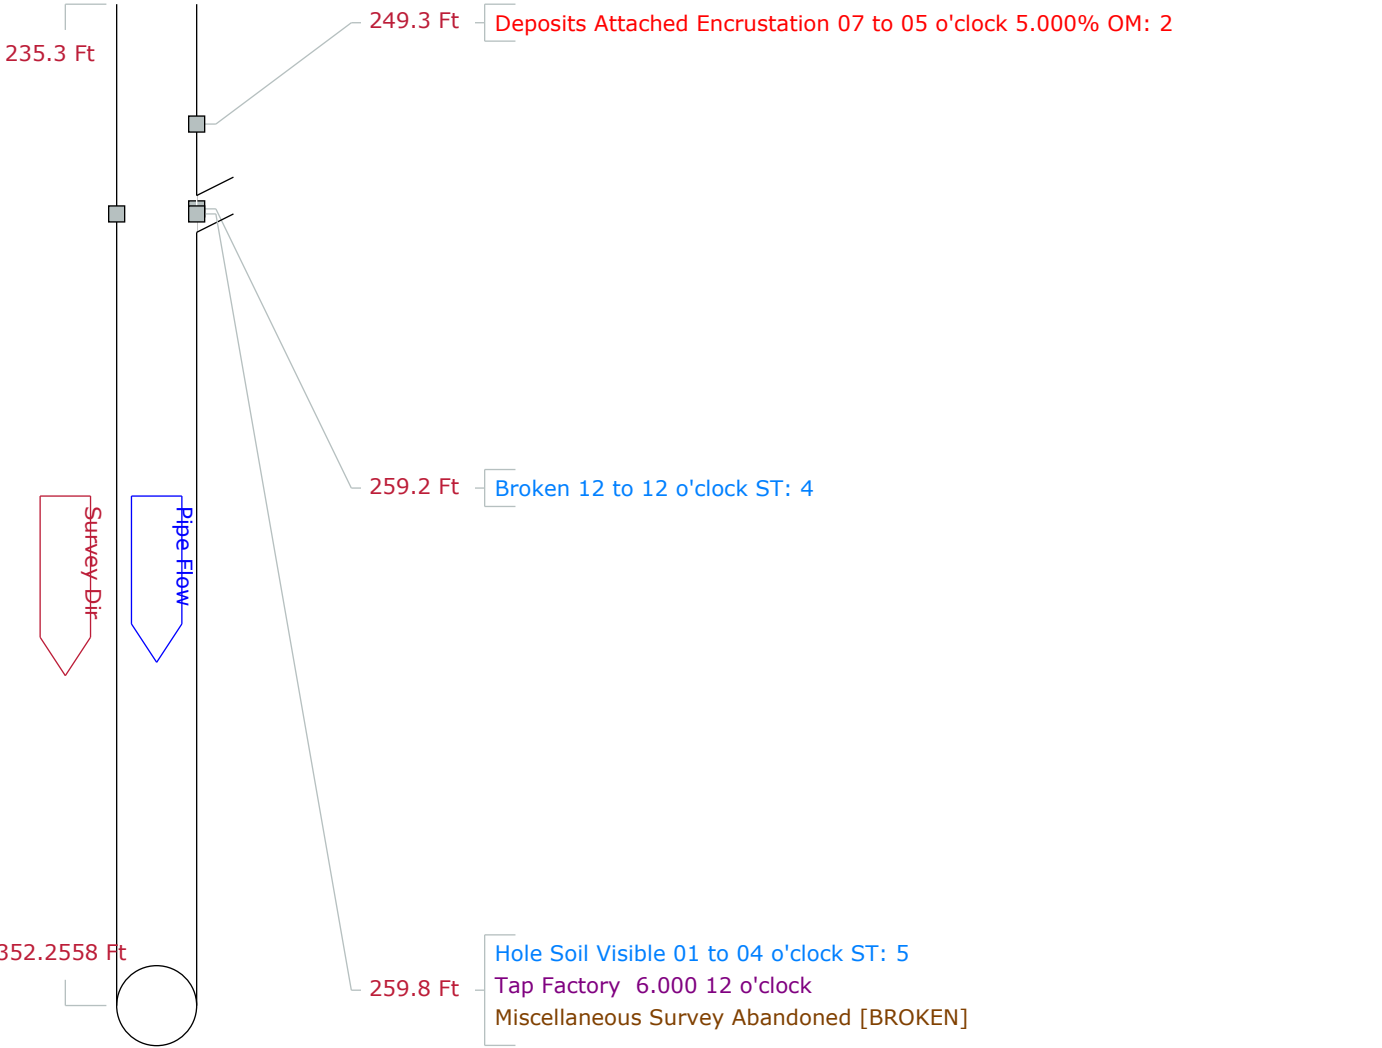
39.4			CM Crack Multiple				J	07	11		
59.2			FM Fracture Multiple				J	12	12		
59.7			TF Tap Factory	6.000				12			
75.8			CM Crack Multiple				J	12	12		
76.3			TFD Tap Factory Defective	6.000				12			ROOTS

81.9			FS Fracture Spiral				J	08	12		
119.7		S01	MWLS Miscellaneous Water Level Sag			20.000					
119.9			FM Fracture Multiple				J	12	12		
121.2			TF Tap Factory	6.000				12

133.4			TF Tap Factory	6.000				12			
152.8		F01	MWLS Miscellaneous Water Level Sag			20.000					
158.6			B Broken				J	12	12		
160.0			TF Tap Factory	6.000				12

165.3			CL Crack Longitudinal				J	09			
193.1		S02	MWLS Miscellaneous Water Level Sag			15.000					
202.1		F02	MWLS Miscellaneous Water Level Sag			15.000

207.3			DAE Deposits Attached Encrustation			5.000		01	04		
207.3			CC Crack Circumferential				J	11	05		
210.0			B Broken				J	12	12		
211.1			TF Tap Factory	6.000				12

Setup	968	Date	2021/08/20	Time	11:59	Up	2016	Down	2018		
Count	Video	CD	Code	Val1	Val2	%	Jnt	Fr	To	ImRef	Remarks
214.1			DAE Deposits Attached Encrustation			5.000	J	03	04		
220.1			B Broken				J	11	12		
220.1			ID Infil Dripper				J	12			
220.1			FS Fracture Spiral					07	11		
221.5			TF Tap Factory	6.000				12			
228.8			DAE Deposits Attached Encrustation			5.000	J	07	11		
228.8			DAE Deposits Attached Encrustation			5.000	J	01	04		
233.3			DAE Deposits Attached Encrustation			5.000	J	08	11		
233.3			CL Crack Longitudinal				J	11			
235.3			DAE Deposits Attached Encrustation			5.000	J	01	04		
249.3			DAE Deposits Attached Encrustation			5.000	J	07	05		
259.2			B Broken					12	12		
259.8			HSV Hole Soil Visible					01	04		
259.8			TF Tap Factory	6.000				12			
259.8			MSA Miscellaneous Survey Abandoned								BROKEN

Willow St. - Full Replacement - MH2016 to 2018

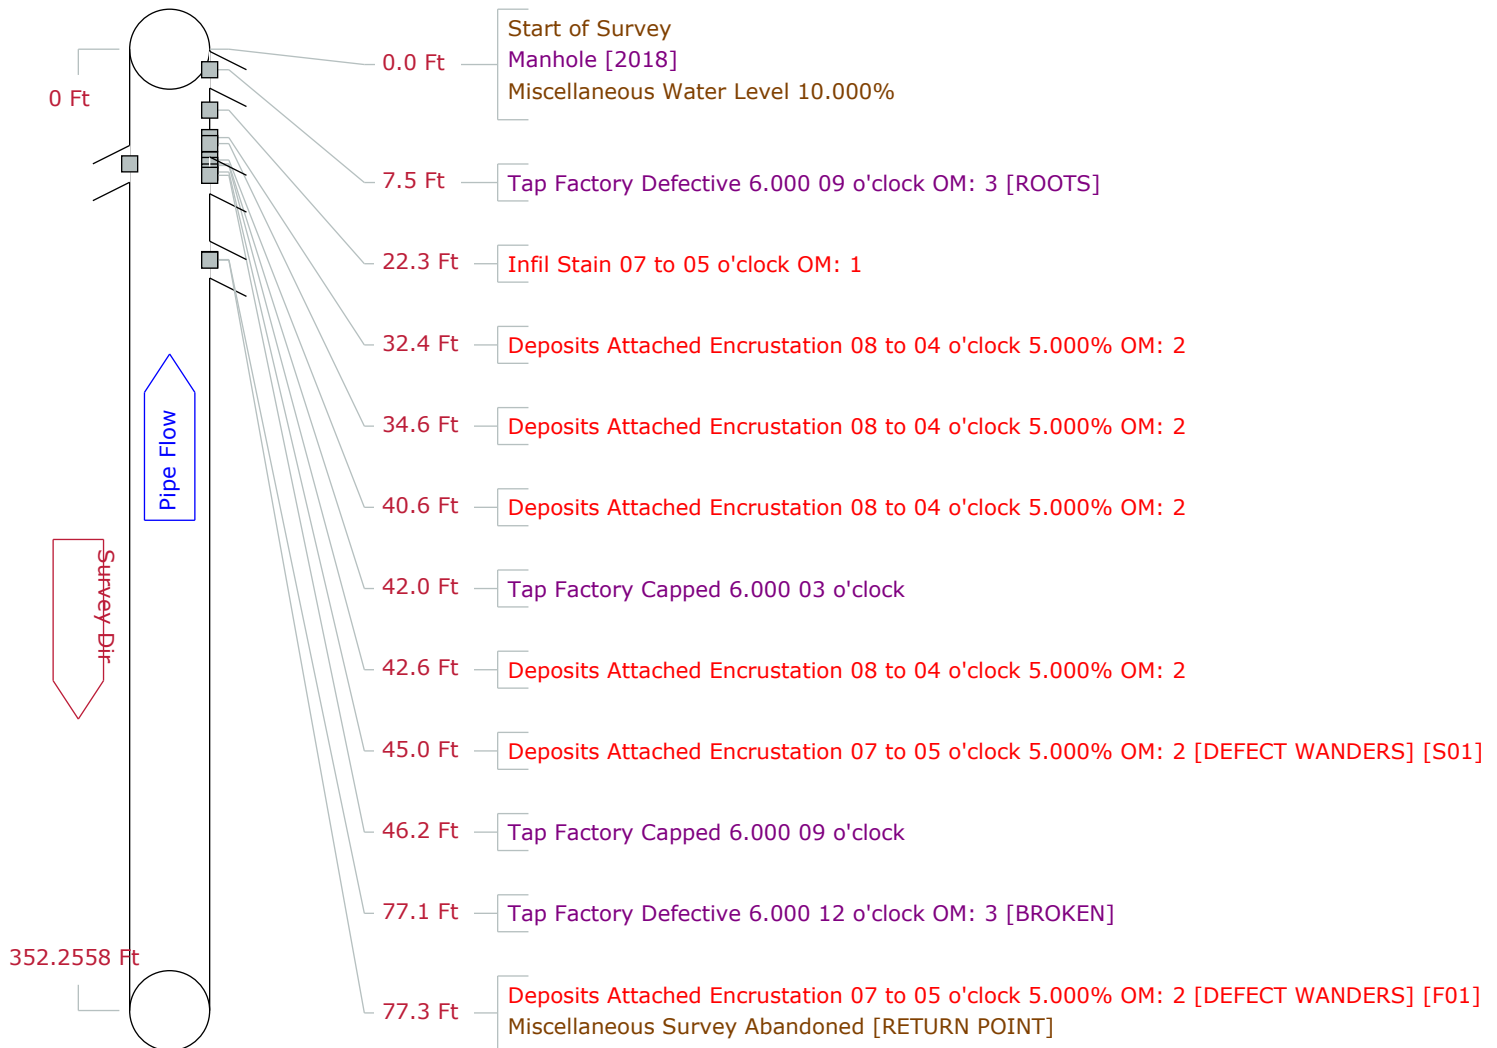
Count Video	CD Code	Val1	Val2	%	Jnt	Fr	To	ImRef	Remarks
0.0	ST								Start of Survey
0.0	AMH								Manhole
0.0	MWL			10.000					Miscellaneous Water Level
7.5	TFD	6.000				09			Tap Factory Defective
22.3	IS				J	07	05		Infil Stain
32.4	DAE			5.000	J	08	04		Deposits Attached Encrustation
34.6	DAE			5.000	J	08	04		Deposits Attached Encrustation
40.6	DAE			5.000	J	08	04		Deposits Attached Encrustation
42.0	TFC	6.000				03			Tap Factory Capped
42.6	DAE			5.000	J	08	04		Deposits Attached Encrustation
45.0	S01 DAE			5.000	J	07	05		Deposits Attached Encrustation
46.2	TFC	6.000				09			Tap Factory Capped
77.1	TFD	6.000				12			Tap Factory Defective
77.3	F01 DAE			5.000	J	07	05		Deposits Attached Encrustation
77.3	MSA								Miscellaneous Survey Abandoned

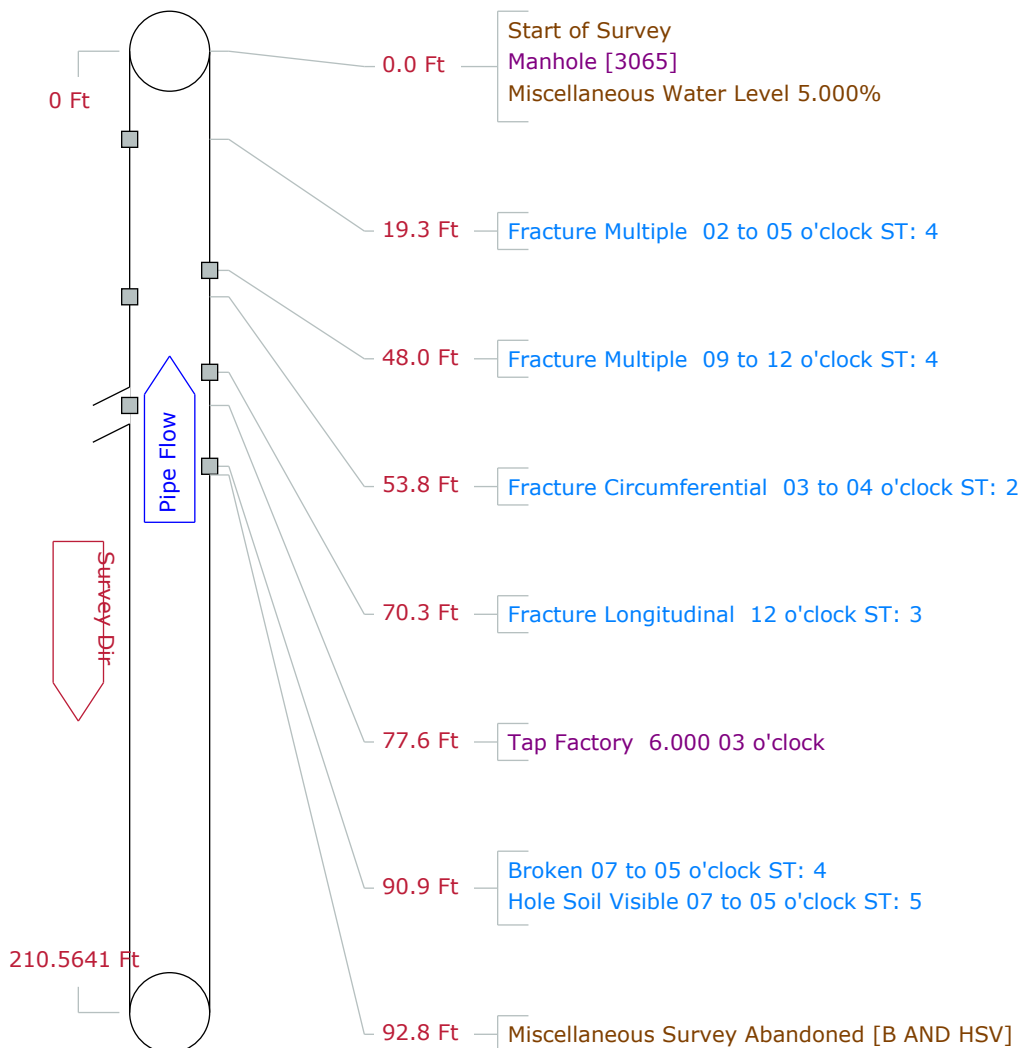
Count Video	CD Code	Val1	Val2	%	Jnt	Fr	To	ImRef	Remarks
0.0	ST	Start of Survey							
0.0	AMH	Manhole							3065
0.0	MWL	Miscellaneous Water Level		5.000					
19.3	FM	Fracture Multiple			J	02	05		
48.0	FM	Fracture Multiple			J	09	12		
53.8	FC	Fracture Circumferential			J	03	04		
70.3	FL	Fracture Longitudinal			J	12			
77.6	TF	Tap Factory	6.000			03			
90.9	B	Broken				07	05		
90.9	HSV	Hole Soil Visible				07	05		
92.8	MSA	Miscellaneous Survey Abandoned							B AND HSV

E. Bacon St. - Spot Replace and Lining - MH3069 to 3065
