Arch Ave. (in grass at Dow) - Spot Replacement - MH1643 to 1643

Pipe Graphic Report of PLR 3664

for Hillsdale

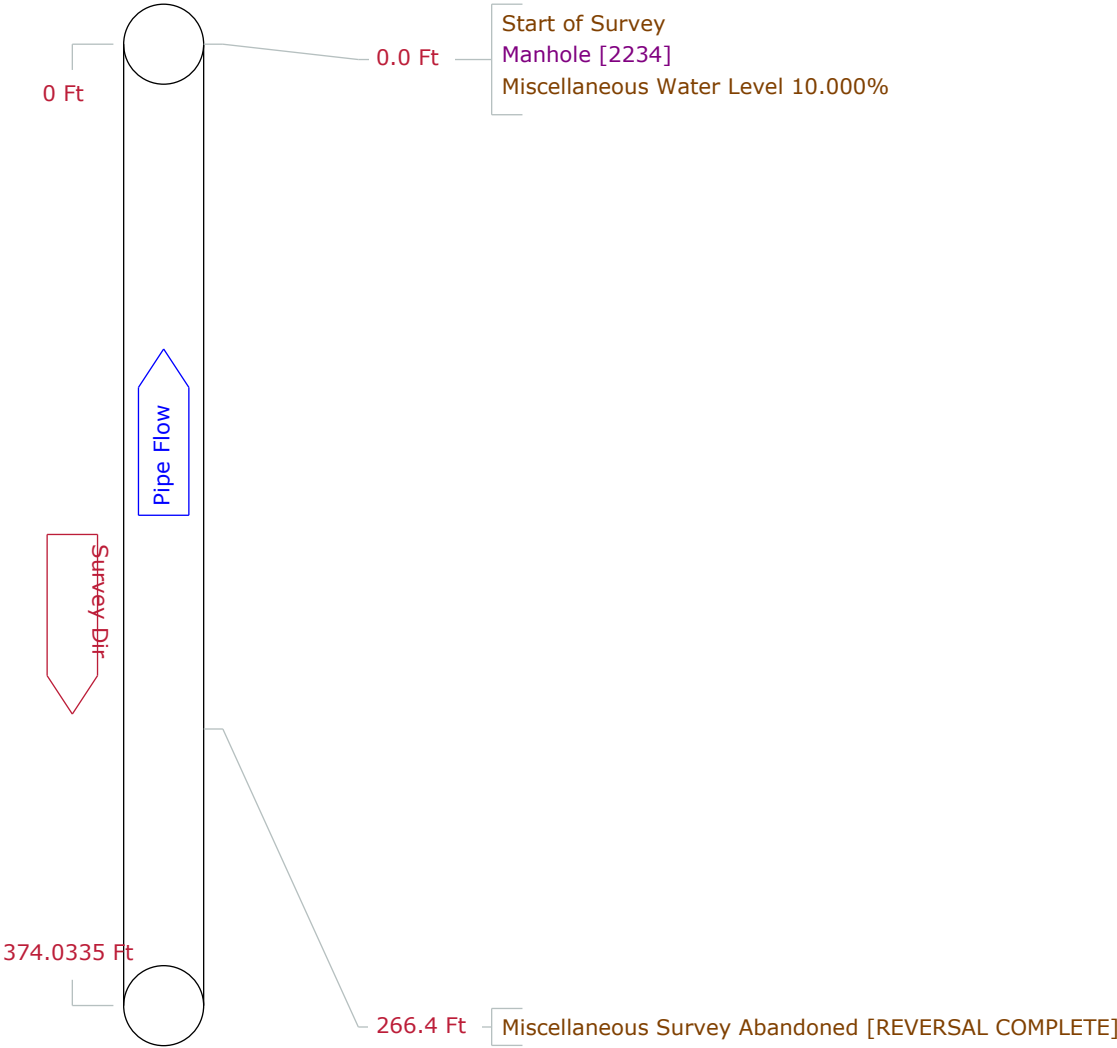
Scores	Structural:	Pipe Rating 9	Pipe Ratings Index 4.5	Quick Rating 5141
	O&M:	Pipe Rating 4	Pipe Ratings Index 1.3	Quick Rating 2112
	Overall	Pipe Rating 13	Pipe Ratings Index 2.6	Quick Rating 5141

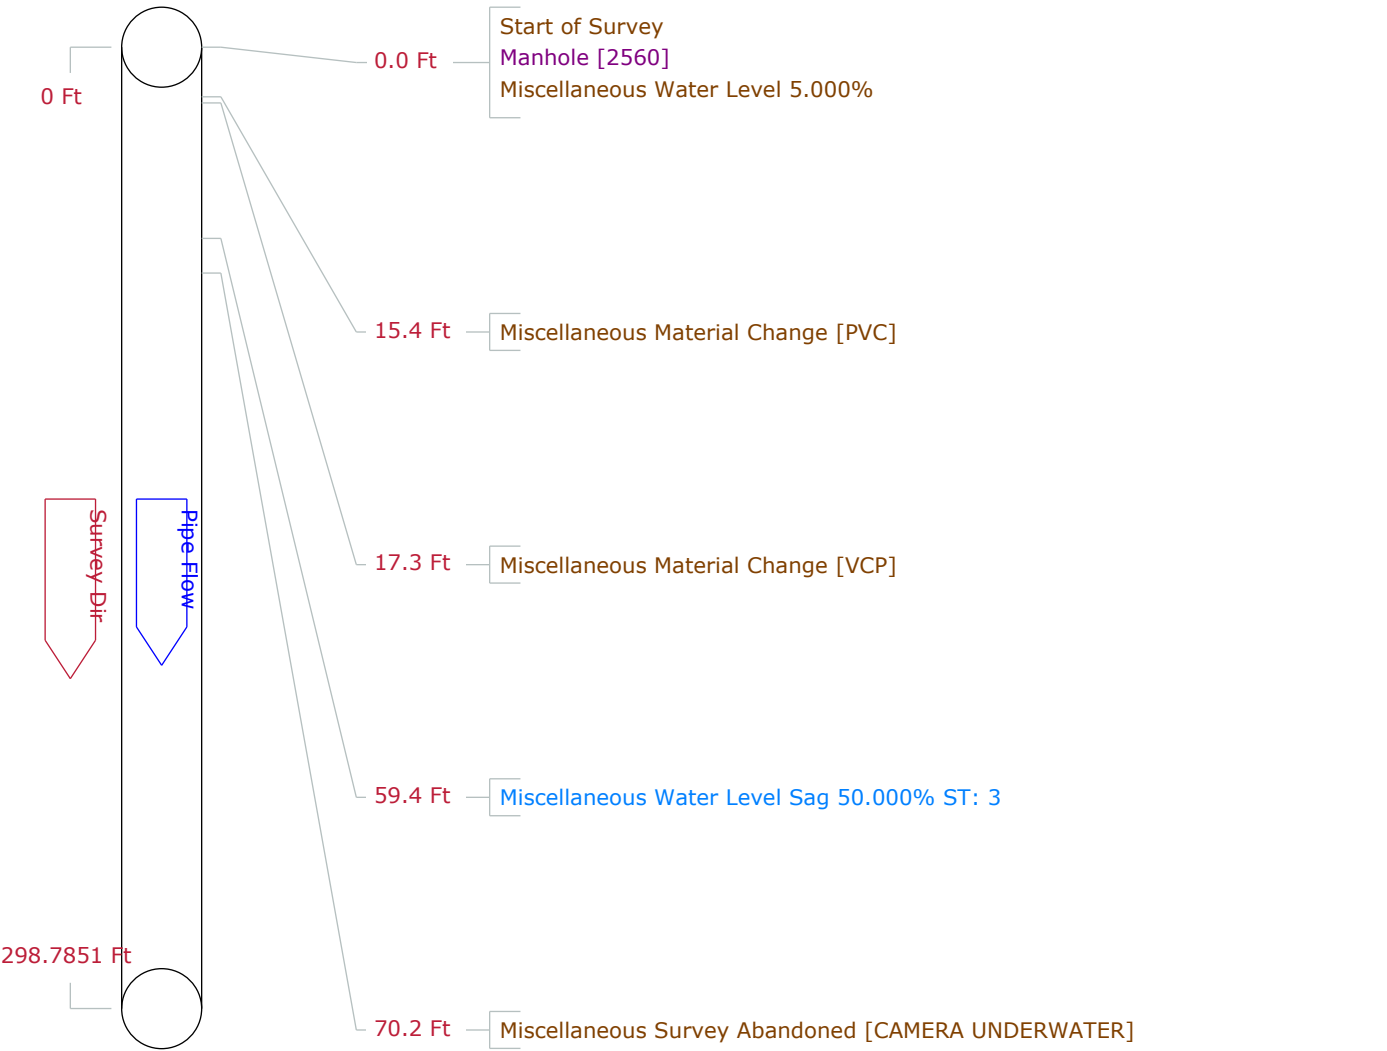
Scores	Structural:	Pipe Rating 19	Pipe Ratings Index 3.2	Quick Rating 5141
	O&M:	Pipe Rating 0	Pipe Ratings Index 0	Quick Rating 0000
	Overall	Pipe Rating 19	Pipe Ratings Index 3.2	Quick Rating 5141

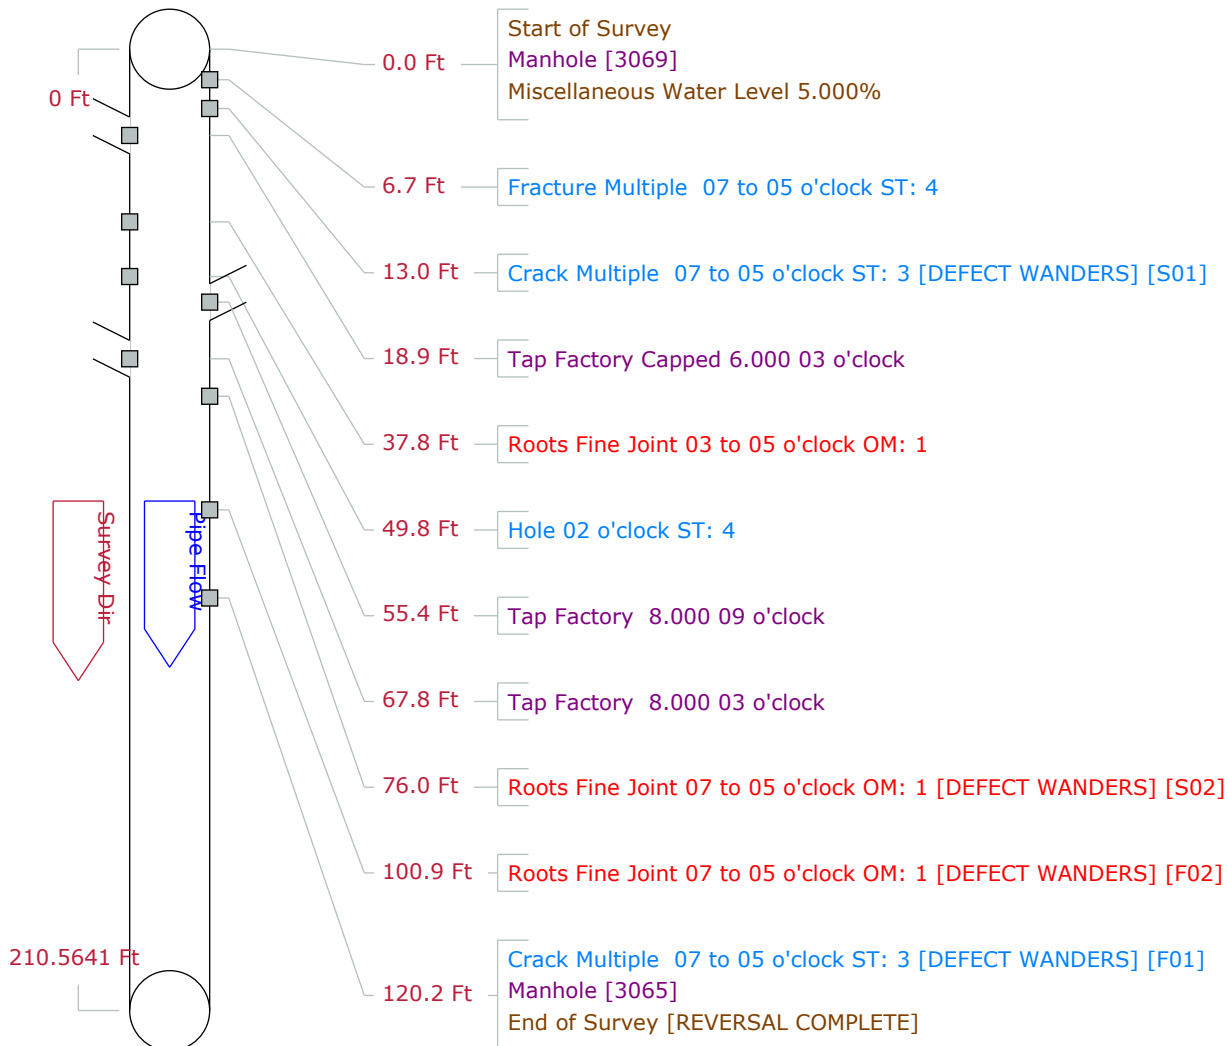
Count Video	CD Code	Val1	Val2	%	Jnt	Fr	To	ImRef	Remarks
0.0	ST								Start of Survey
0.0	AMH								Manhole
0.0	MWL			5.000					Miscellaneous Water Level
6.7	FM				J	07	05		Fracture Multiple
13.0	S01 CM				J	07	05		Crack Multiple
18.9	TFC	6.000				03			Tap Factory Capped
37.8	RFJ				J	03	05		Roots Fine Joint
49.8	H					02			Hole
55.4	TF	8.000				09			Tap Factory
67.8	TF	8.000				03			Tap Factory
76.0	S02 RFJ				J	07	05		Roots Fine Joint
100.9	F02 RFJ				J	07	05		Roots Fine Joint
120.2	F01 CM				J	07	05		Crack Multiple
120.2	AMH								Manhole
120.2	FH								End of Survey

E. Bacon St. - Spot Replace and Lining - MH3069 to 3065

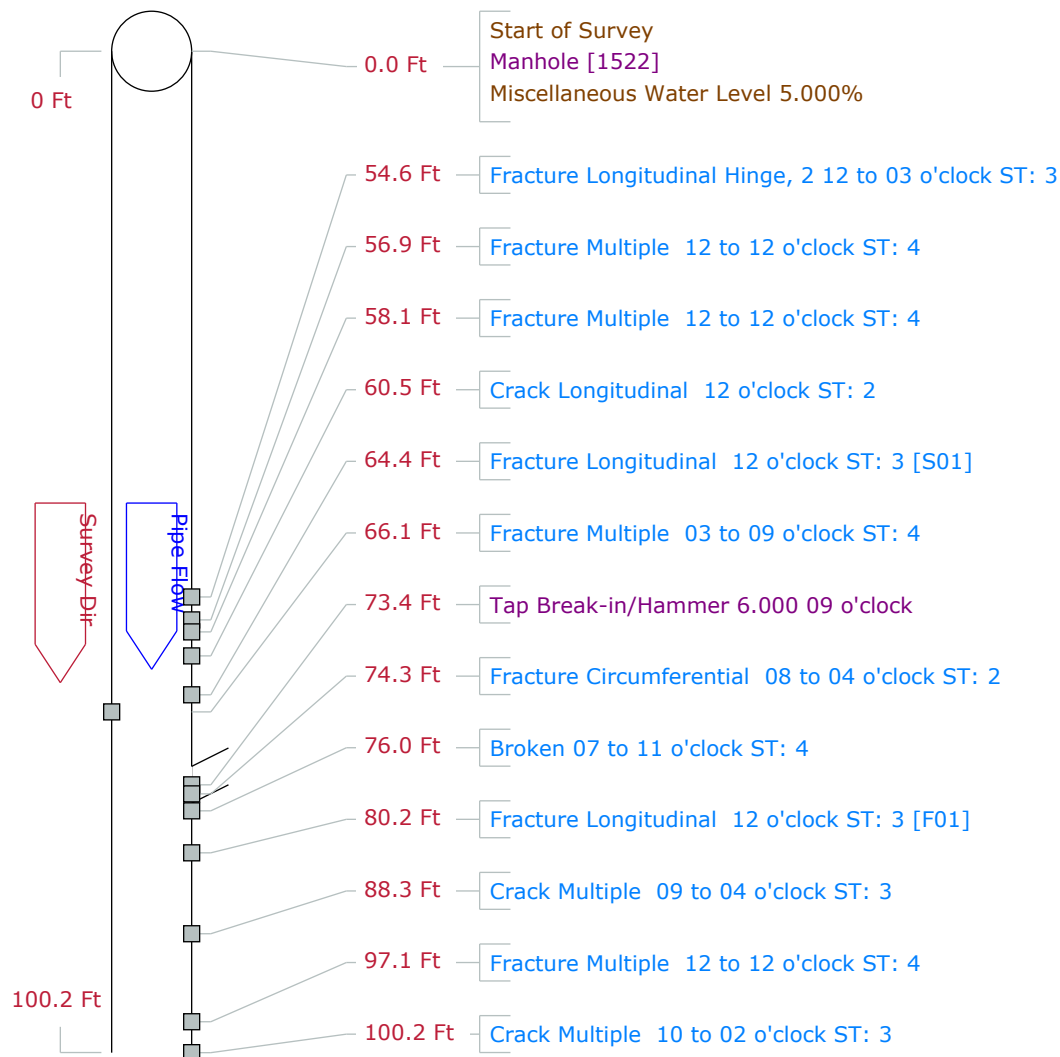
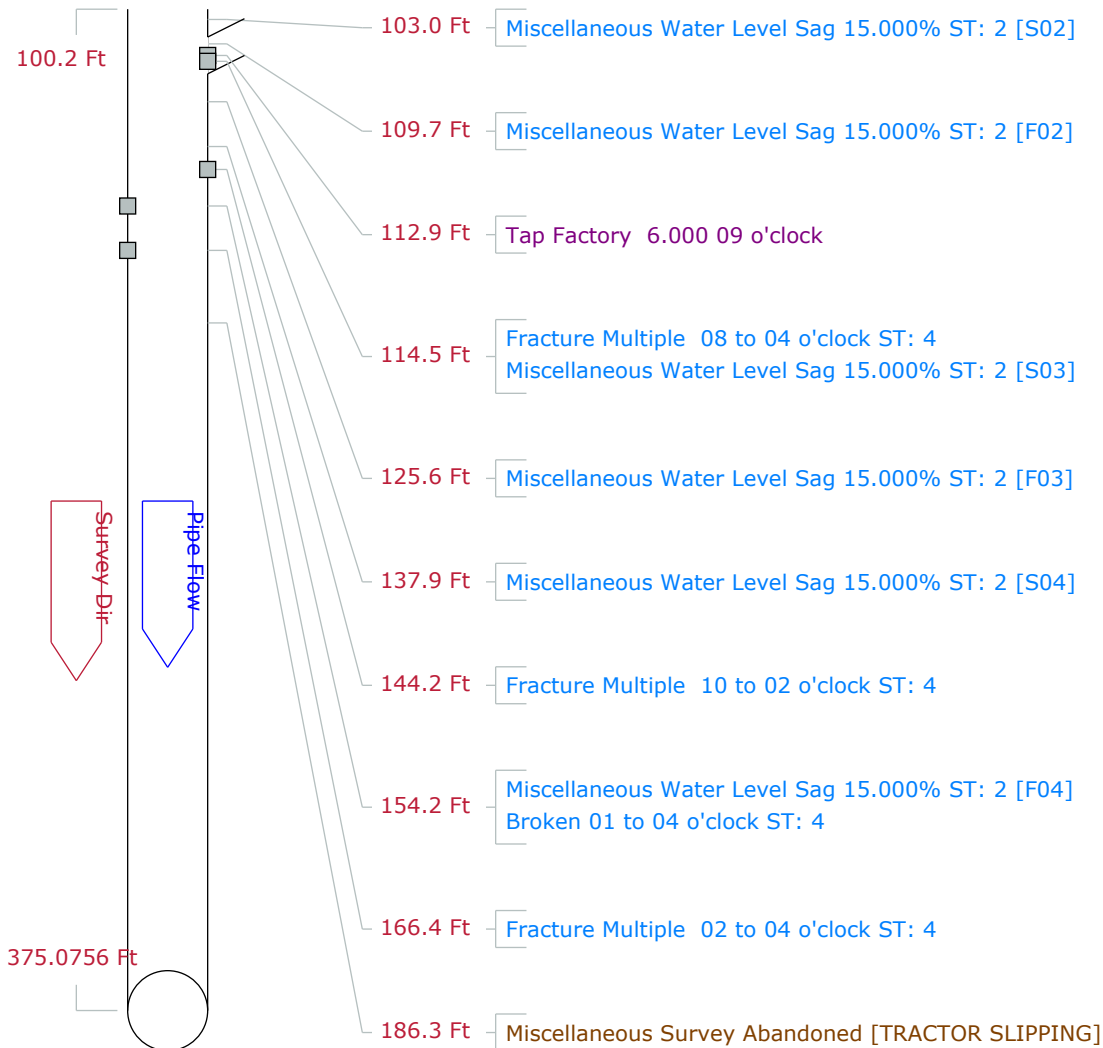
Pipe Graphic Report of PLR 4037

54.6			FH2 Fracture Longitudinal Hinge, 2					12	03			
56.9			FM Fracture Multiple				J	12	12			
58.1			FM Fracture Multiple				J	12	12			
60.5			CL Crack Longitudinal				J	12

64.4		S01	FL Fracture Longitudinal				J	12				
66.1			FM Fracture Multiple				J	03	09			
73.4			TB Tap Break-in/Hammer	6.000				09				
74.3			FC Fracture Circumferential					08	04

76.0			B Broken				J	07	11			
80.2		F01	FL Fracture Longitudinal				J	12				
88.3			CM Crack Multiple				J	09	04			
97.1			FM Fracture Multiple					12	12

100.2			CM Crack Multiple				J	10	02			
103.0		S02	MWLS Miscellaneous Water Level Sag			15.000						
109.7		F02	MWLS Miscellaneous Water Level Sag			15.000

S. Broad St. (M-99 - MDOT) - Spot Replace and Lining - MH1521 to 1522

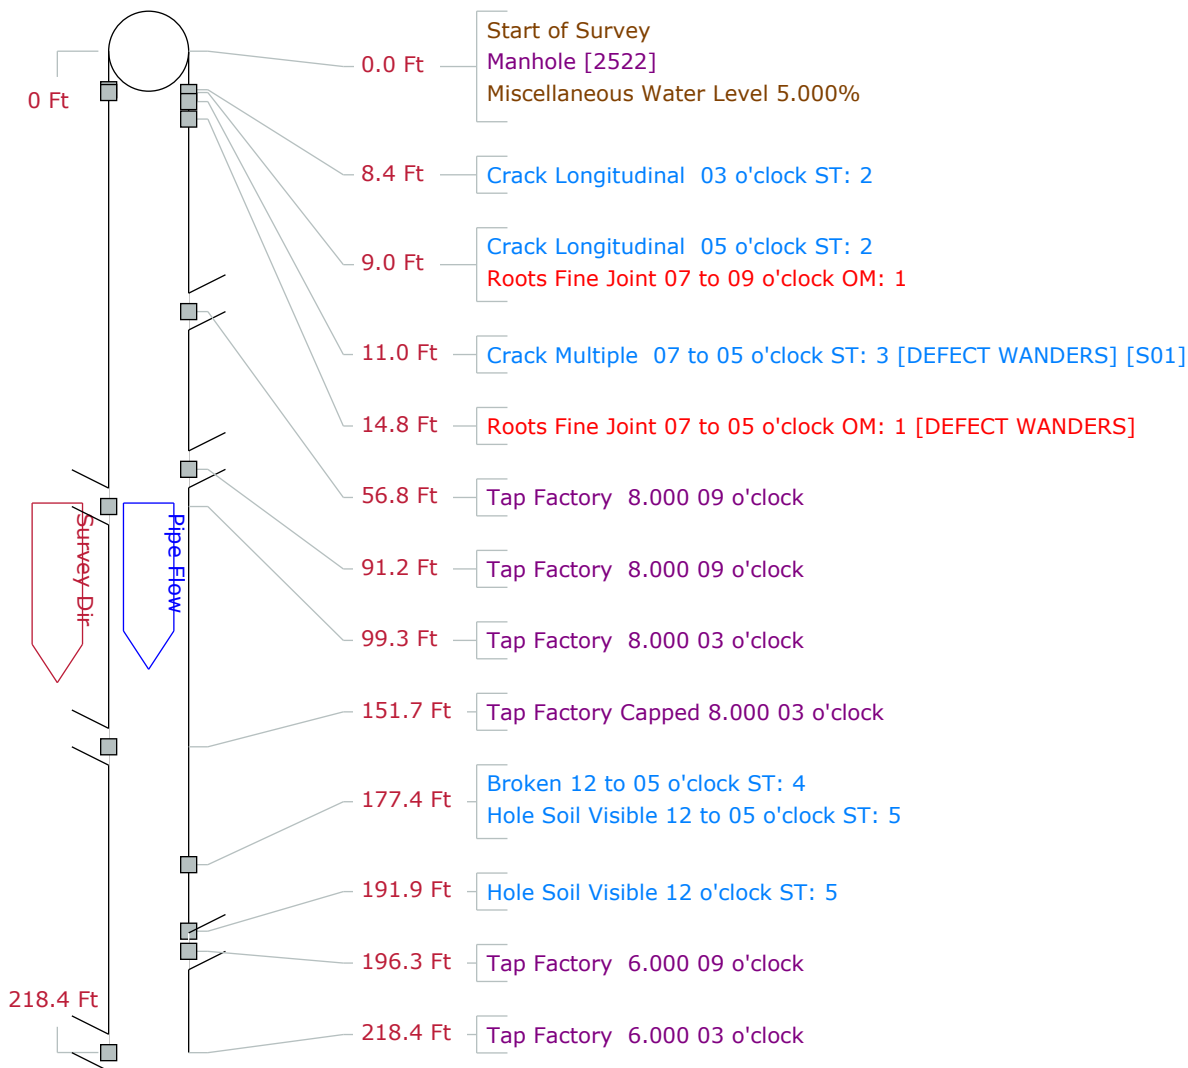
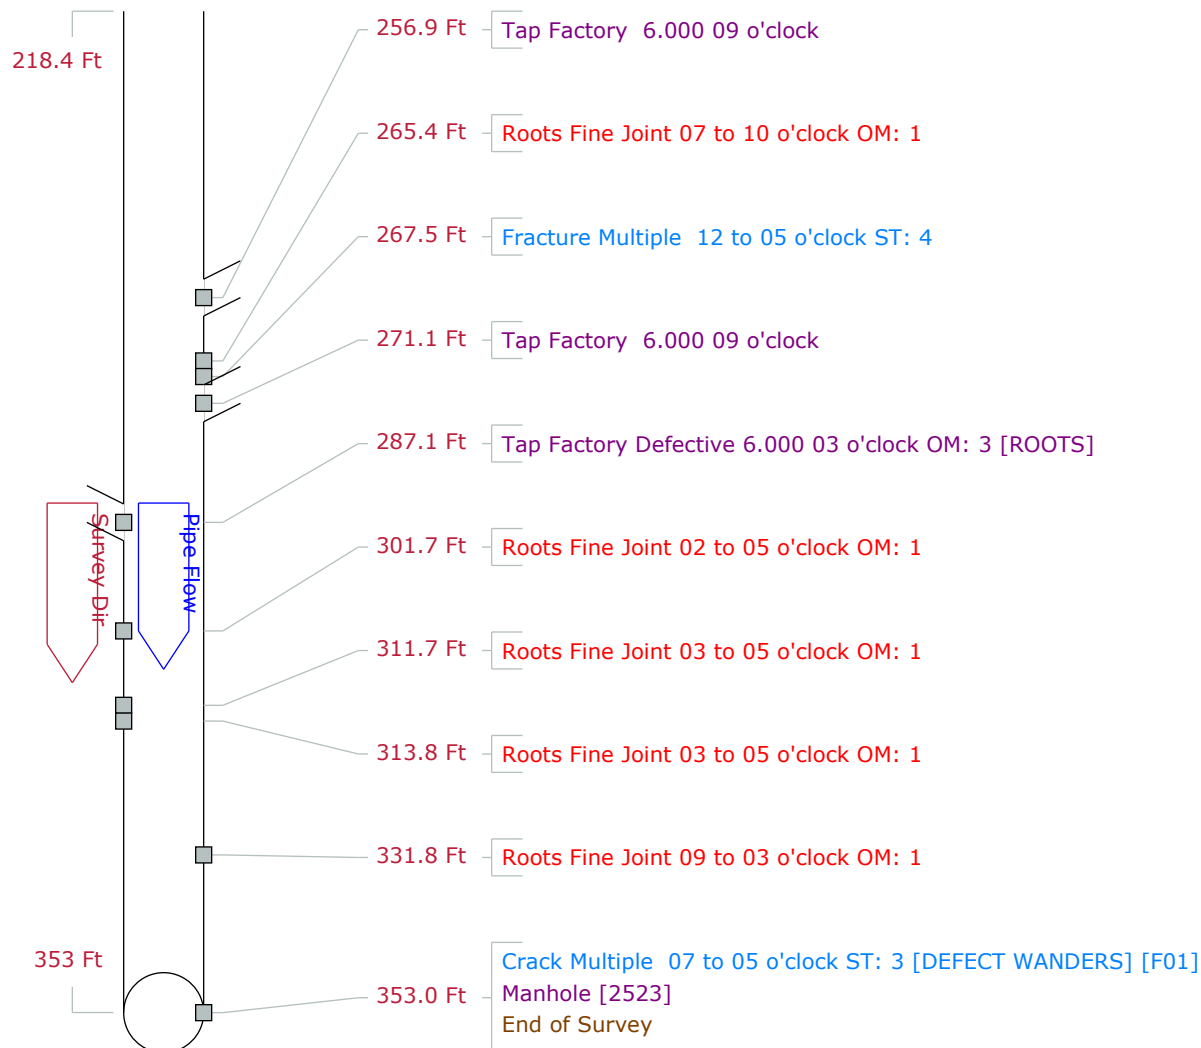
Pipe Graphic Report of PLR 4298

Counter:177.4
Code:B(Broken)
Percent:
From:12

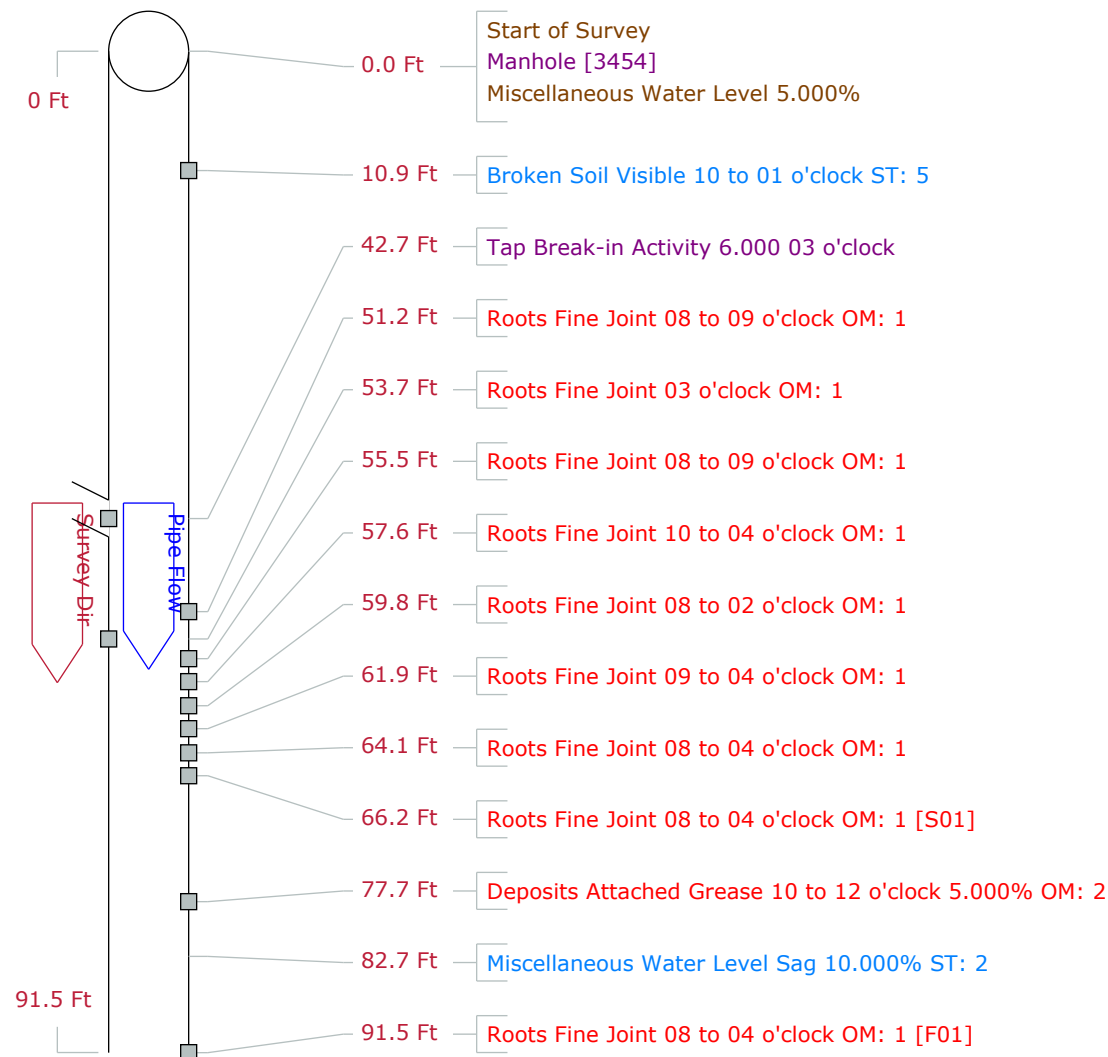
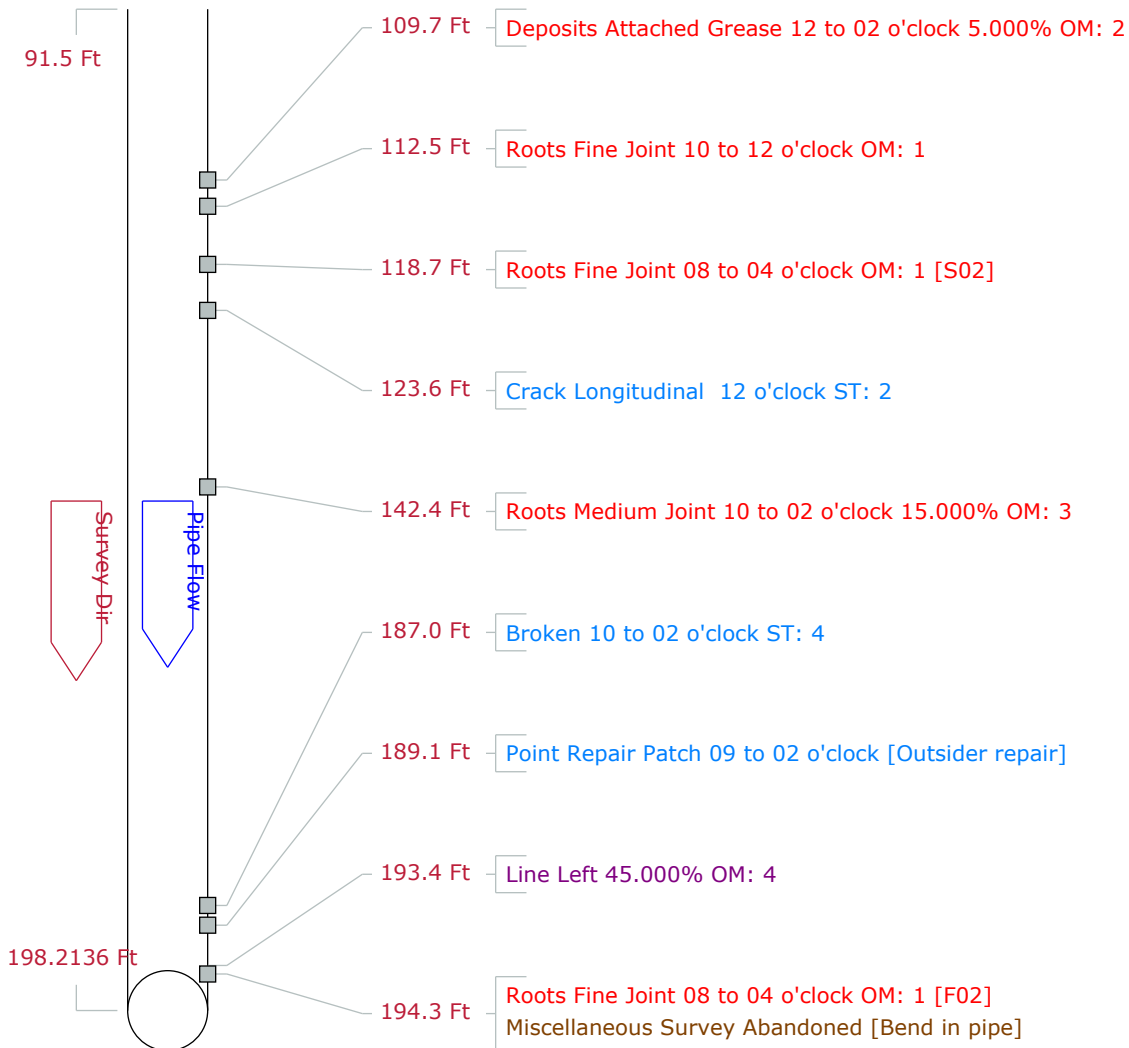
Pipe Graphic Report of PLR 3912

Scores	Structural:	Pipe Rating	13	Pipe Ratings Index	3.3	Quick Rating	5141
	O&M:	Pipe Rating	39	Pipe Ratings Index	1.2	Quick Rating	4131
	Overall	Pipe Rating	52	Pipe Ratings Index	1.4	Quick Rating	5142

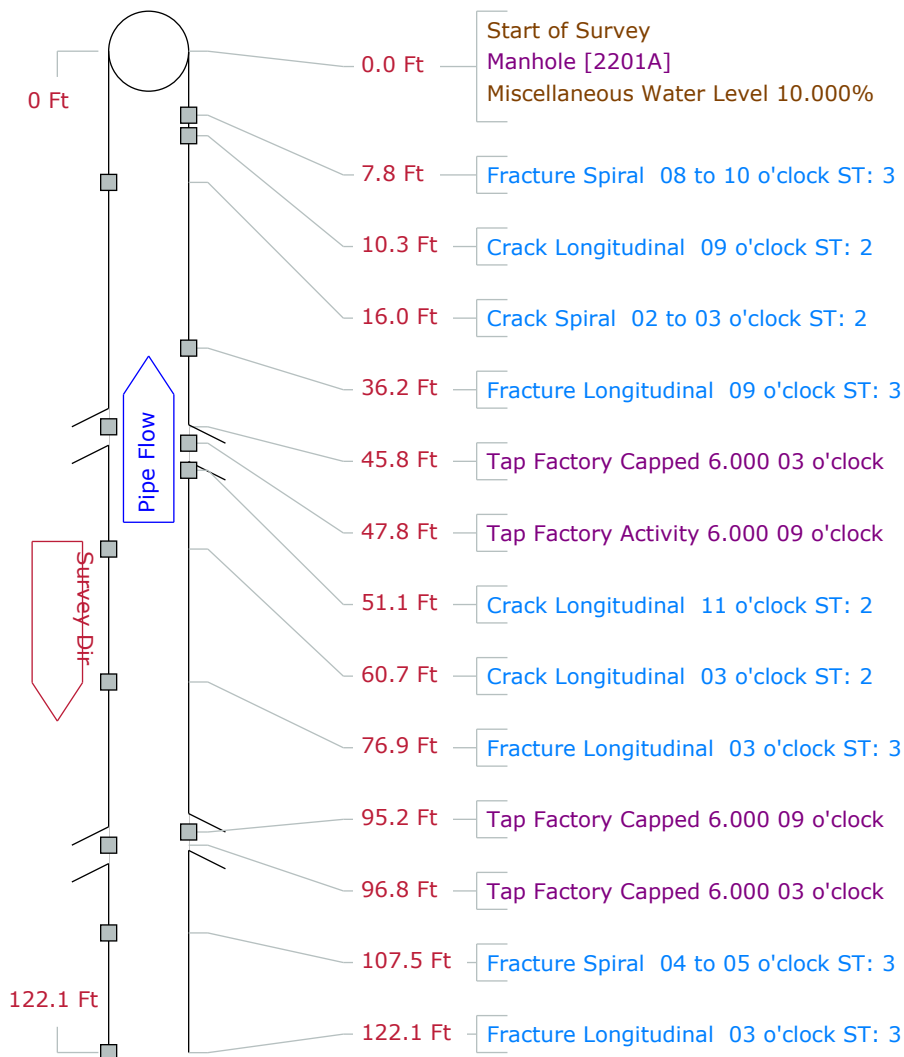
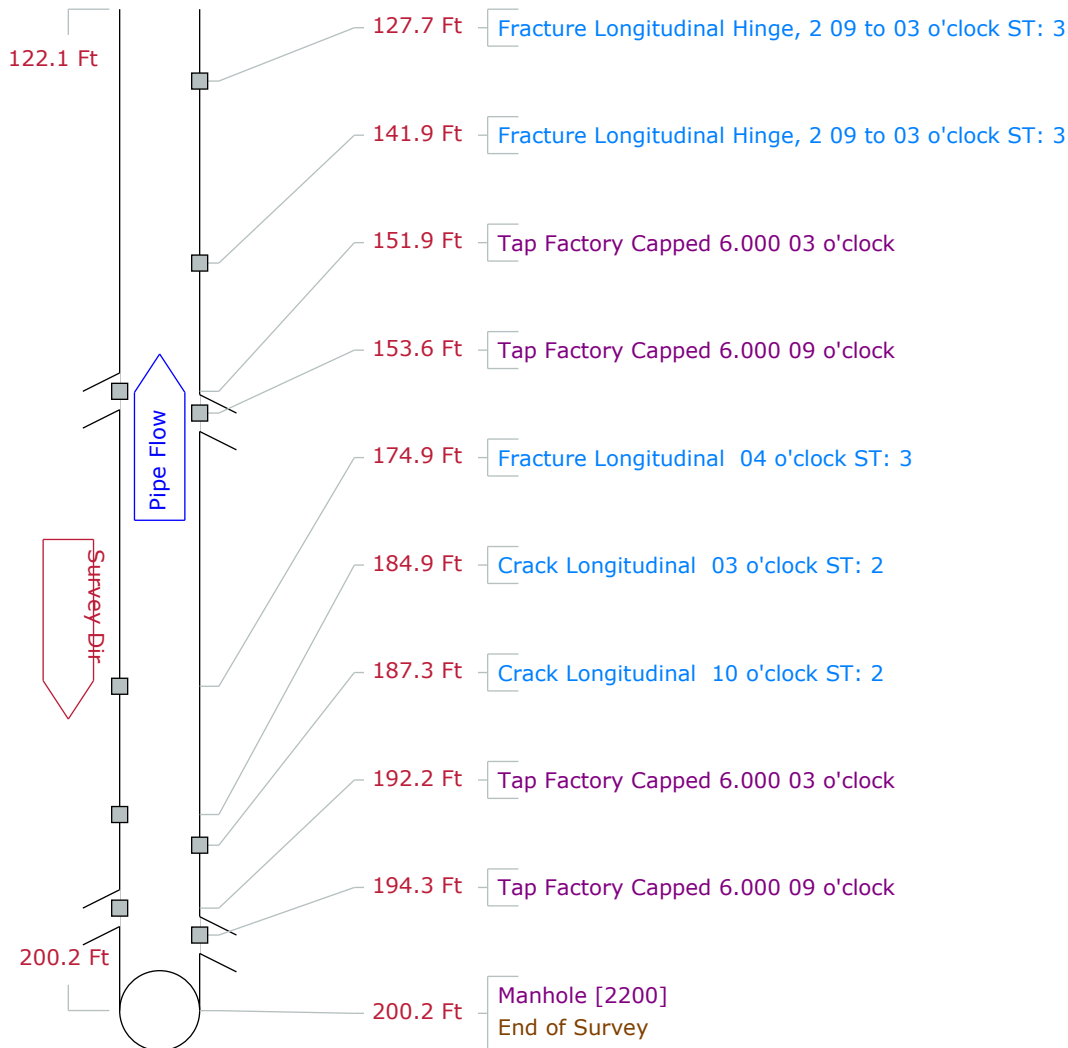
Pipe Graphic Report of PLR 4186A

187.3			CL Crack Longitudinal				J	10

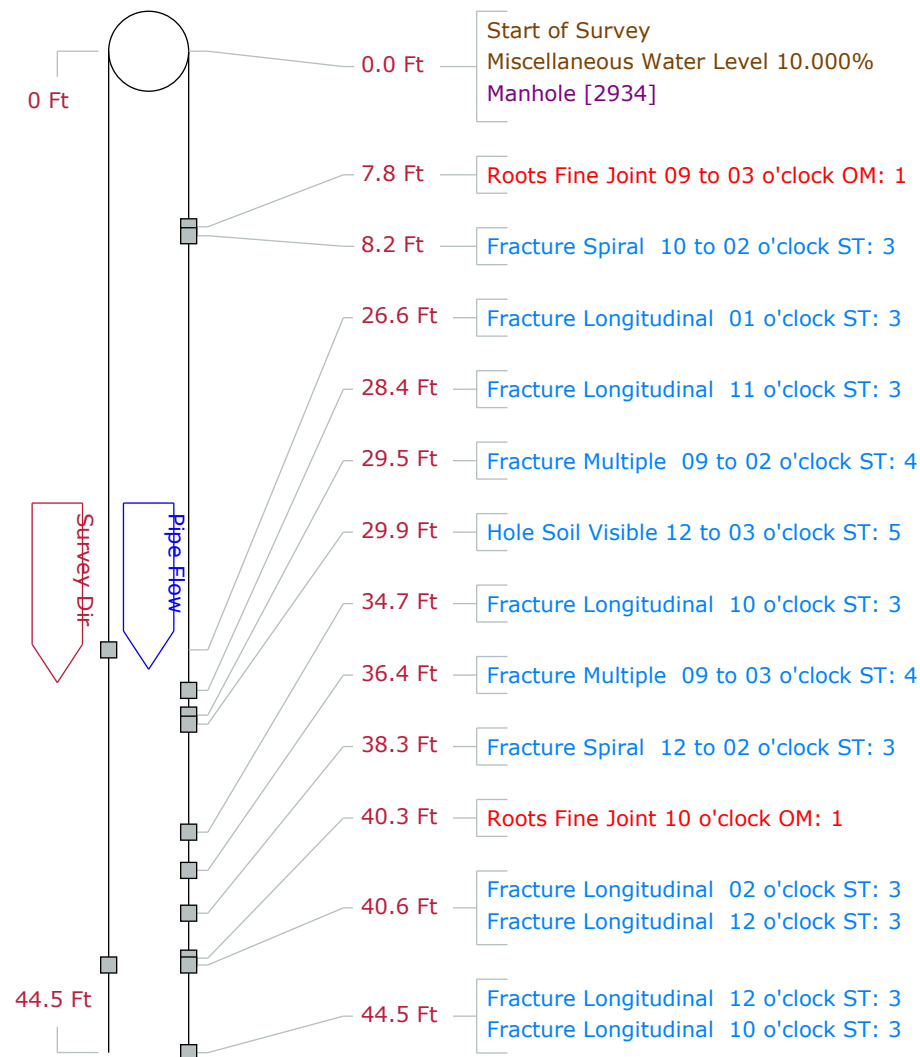
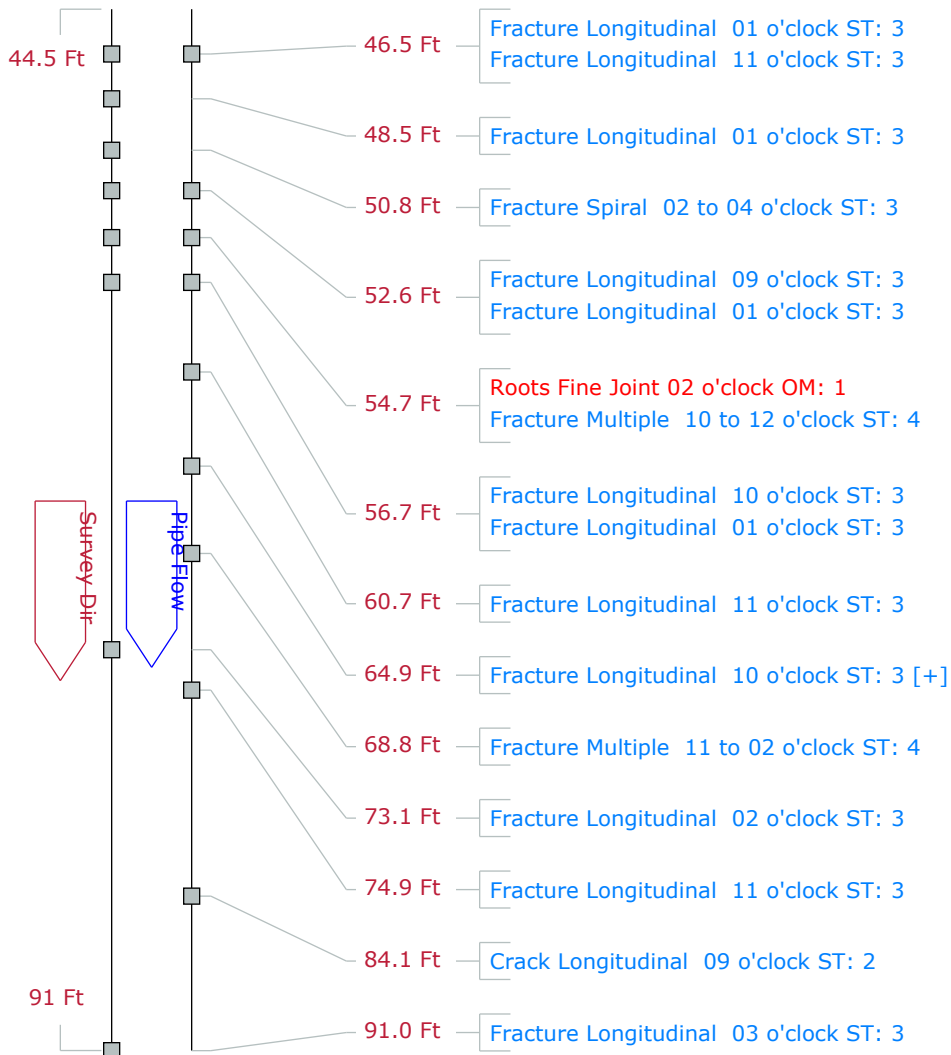
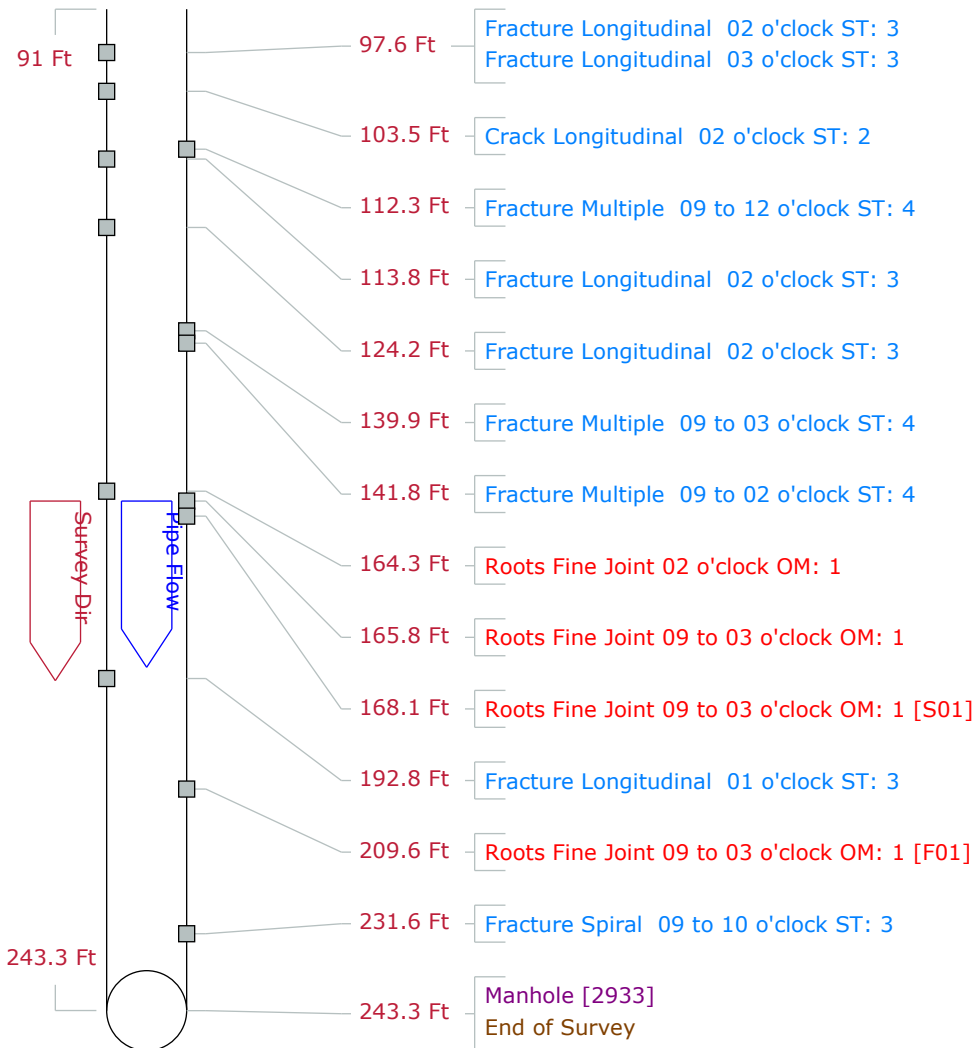
Tabular Report of PSR 4048
for Hillsdale

7.8			RFJ Roots Fine Joint				J	09	03			
8.2			FS Fracture Spiral				J	10	02			
26.6			FL Fracture Longitudinal				J	01				
28.4			FL Fracture Longitudinal				J	11

29.5			FM Fracture Multiple				J	09	02			
29.9			HSV Hole Soil Visible				J	12	03			
34.7			FL Fracture Longitudinal				J	10				
36.4			FM Fracture Multiple				J	09	03

38.3			FS Fracture Spiral				J	12	02			
40.3			RFJ Roots Fine Joint				J	10				
40.6			FL Fracture Longitudinal				J	02				
40.6			FL Fracture Longitudinal				J	12

44.5			FL Fracture Longitudinal				J	12				
44.5			FL Fracture Longitudinal				J	10				
46.5			FL Fracture Longitudinal				J	01				
46.5			FL Fracture Longitudinal				J	11

48.5			FL Fracture Longitudinal				J	01				
50.8			FS Fracture Spiral				J	02	04			
52.6			FL Fracture Longitudinal				J	09				
52.6			FL Fracture Longitudinal				J	01

54.7			FM	Fracture Multiple				J	10	12		
56.7			FL	Fracture Longitudinal				J	10			
56.7			FL	Fracture Longitudinal				J	01			
60.7			FL	Fracture Longitudinal				J	11

64.9			FL	Fracture Longitudinal				J	10			+
68.8			FM	Fracture Multiple				J	11	02		
73.1			FL	Fracture Longitudinal				J	02			
74.9			FL	Fracture Longitudinal				J	11

84.1			CL	Crack Longitudinal				J	09			
91.0			FL	Fracture Longitudinal				J	03			
97.6			FL	Fracture Longitudinal				J	02			
97.6			FL	Fracture Longitudinal				J	03

103.5			CL	Crack Longitudinal				J	02			
112.3			FM	Fracture Multiple				J	09	12		
113.8			FL	Fracture Longitudinal				J	02			
124.2			FL	Fracture Longitudinal				J	02

139.9			FM	Fracture Multiple				J	09	03		
141.8			FM	Fracture Multiple				J	09	02		
164.3			RFJ	Roots Fine Joint				J	02			
165.8			RFJ	Roots Fine Joint				J	09	03

168.1		S01	RFJ	Roots Fine Joint				J	09	03		
192.8			FL	Fracture Longitudinal				J	01			
209.6		F01	RFJ	Roots Fine Joint				J	09	03		
231.6			FS	Fracture Spiral				J	09	10

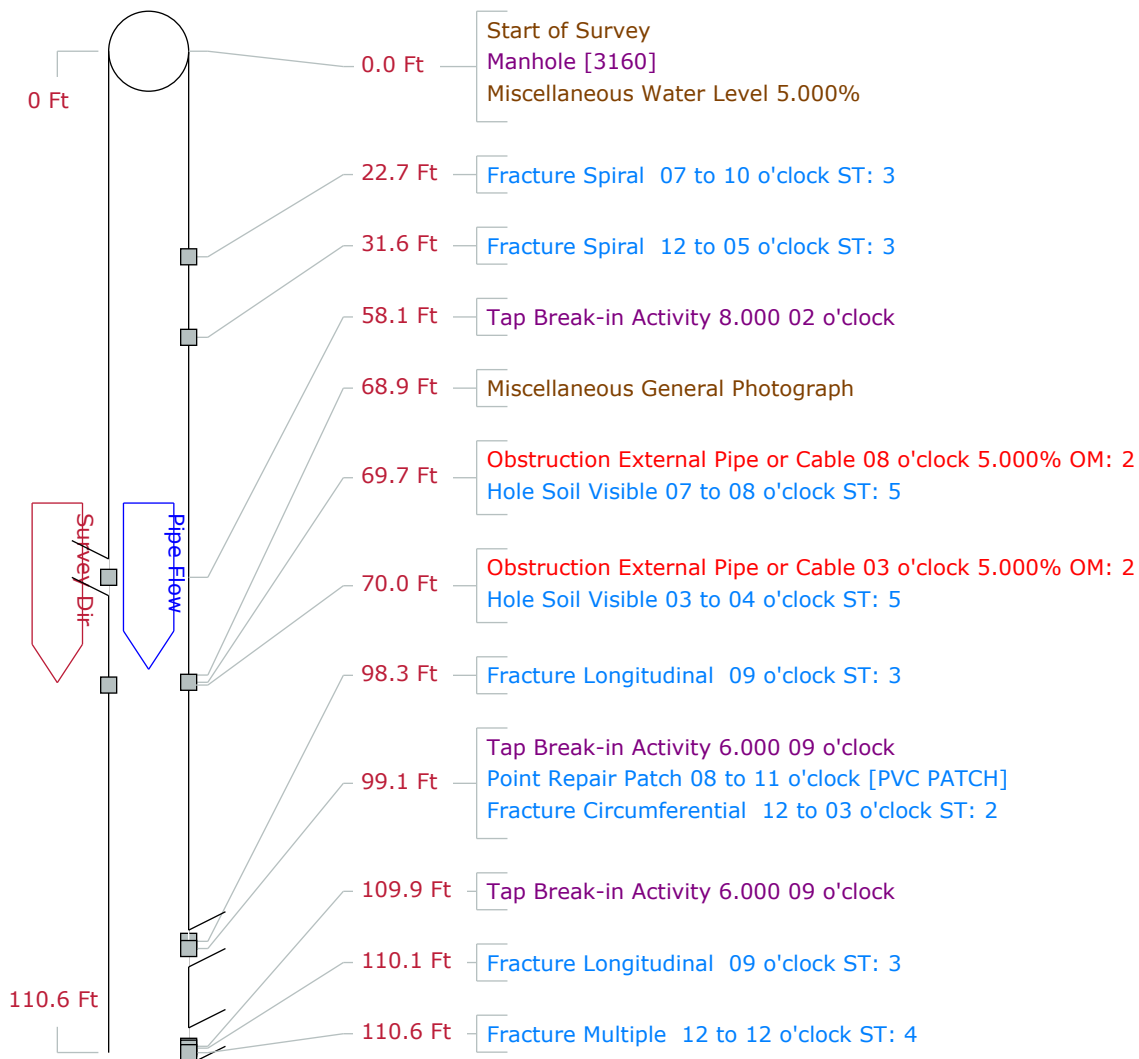
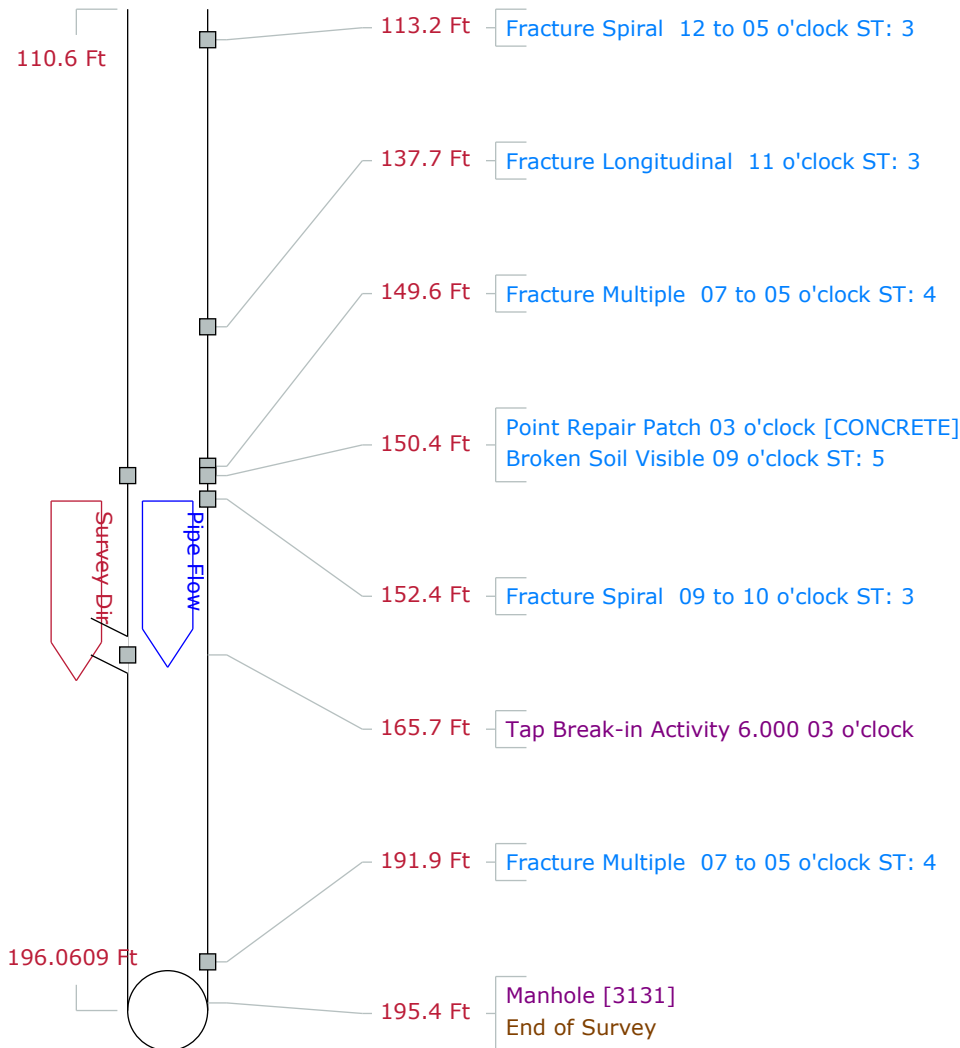
Tabular Report of PSR 3790
for Hillsdale

22.7			FS Fracture Spiral				J	07	10			
31.6			FS Fracture Spiral				J	12	05			
58.1			TBA Tap Break-in Activity	8.000				02				
68.9			MGP Miscellaneous General Photograph

70.0			HSV Hole Soil Visible					03	04			
98.3			FL Fracture Longitudinal				J	09				
99.1			TBA Tap Break-in Activity	6.000				09				
99.1			RPP Point Repair Patch					08	11			PVC PATCH

99.1			FC Fracture Circumferential				J	12	03			
109.9			TBA Tap Break-in Activity	6.000				09				
110.1			FL Fracture Longitudinal				J	09				
110.6			FM Fracture Multiple				J	12	12

113.2			FS Fracture Spiral				J	12	05			
137.7			FL Fracture Longitudinal				J	11				
149.6			FM Fracture Multiple				J	07	05			
150.4			RPP Point Repair Patch					03				CONCRETE

150.4			BSV Broken Soil Visible					09

Setup	41	Date	2021/04/08		Time	14:49		Up	3160				Down	3131			
Count	Video	CD	Code			Val1	Val2	%	Jnt	Fr	To	ImRef	Remarks				
152.4			FS	Fracture Spiral						J	09	10					
165.7			TBA	Tap Break-in Activity			6.000				03						
191.9			FM	Fracture Multiple						J	07	05					
195.4			AMH	Manhole										3131			
195.4			FH	End of Survey

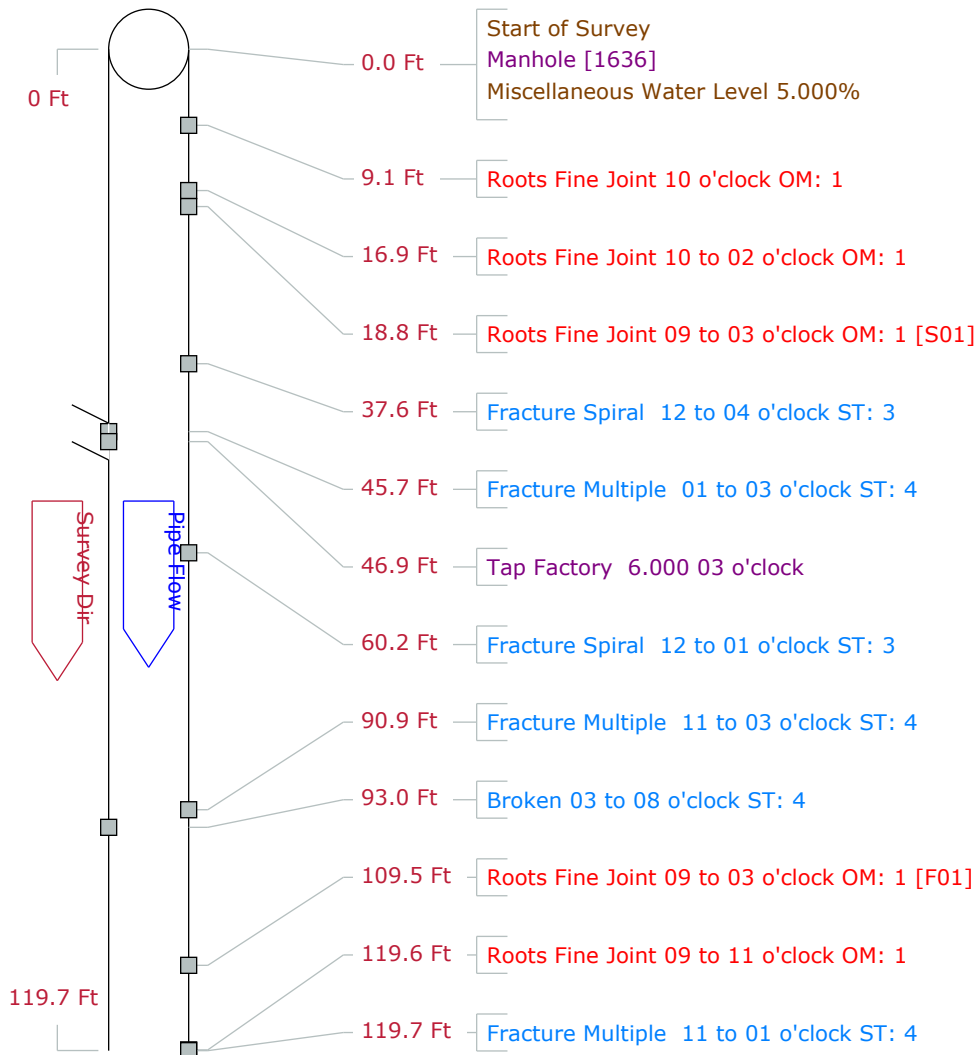
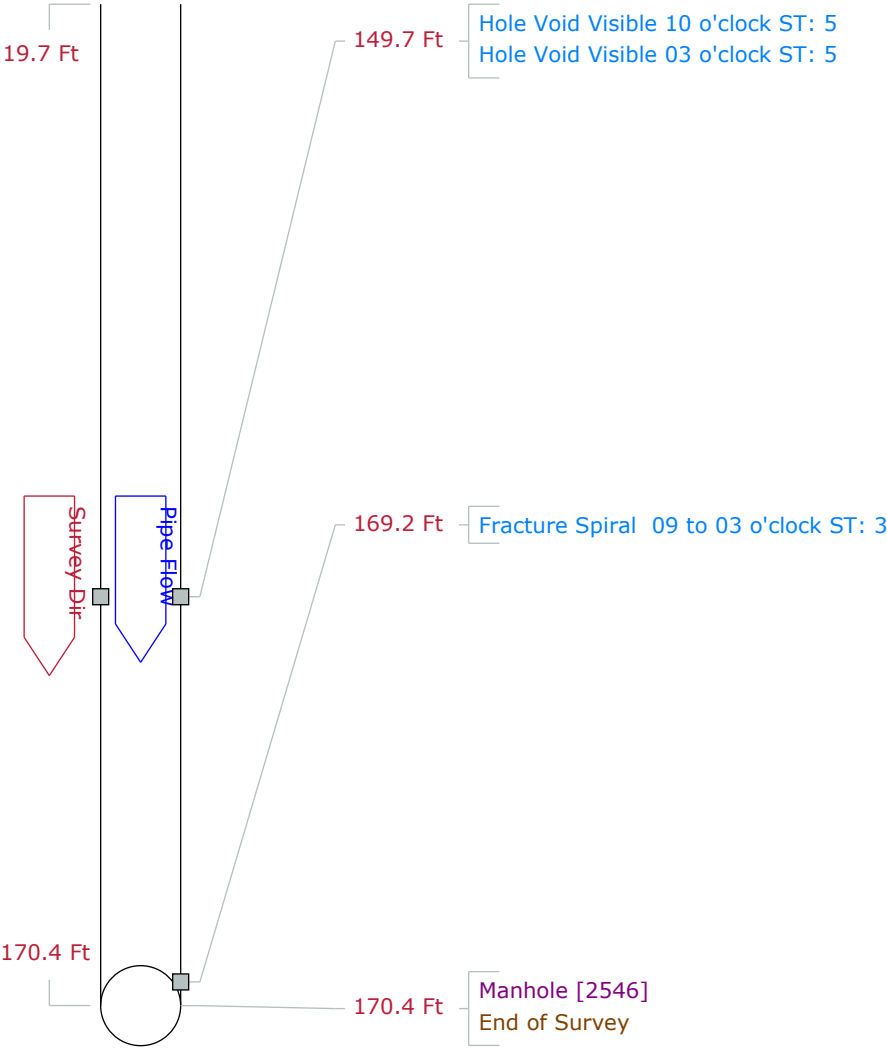
Tabular Report of PSR 4000

Count	Video	CD Code	Val1	Val2	%	Jnt	Fr	To	ImRef	Remarks
0.0		ST	Start of Survey							
0.0		AMH	Manhole							1636
0.0		MWL	Miscellaneous Water Level		5.000					
9.1		RFJ	Roots Fine Joint			J	10			
16.9		RFJ	Roots Fine Joint			J	10	02		
18.8	S01	RFJ	Roots Fine Joint			J	09	03		
37.6		FS	Fracture Spiral			J	12	04		
45.7		FM	Fracture Multiple			J	01	03		
46.9		TF	Tap Factory	6.000			03			
60.2		FS	Fracture Spiral			J	12	01		
90.9		FM	Fracture Multiple			J	11	03		
93.0		B	Broken			J	03	08		
109.5	F01	RFJ	Roots Fine Joint			J	09	03		
119.6		RFJ	Roots Fine Joint			J	09	11		
119.7		FM	Fracture Multiple			J	11	01		
149.7		HVV	Hole Void Visible				10			
149.7		HVV	Hole Void Visible				03			
169.2		FS	Fracture Spiral			J	09	03		
170.4		AMH	Manhole							2546
170.4		FH	End of Survey
