Arch Ave. (in grass at Dow) - Spot Replacement - MH1643 to 1643

Pipe Graphic Report of PLR 3664

for Hillsdale

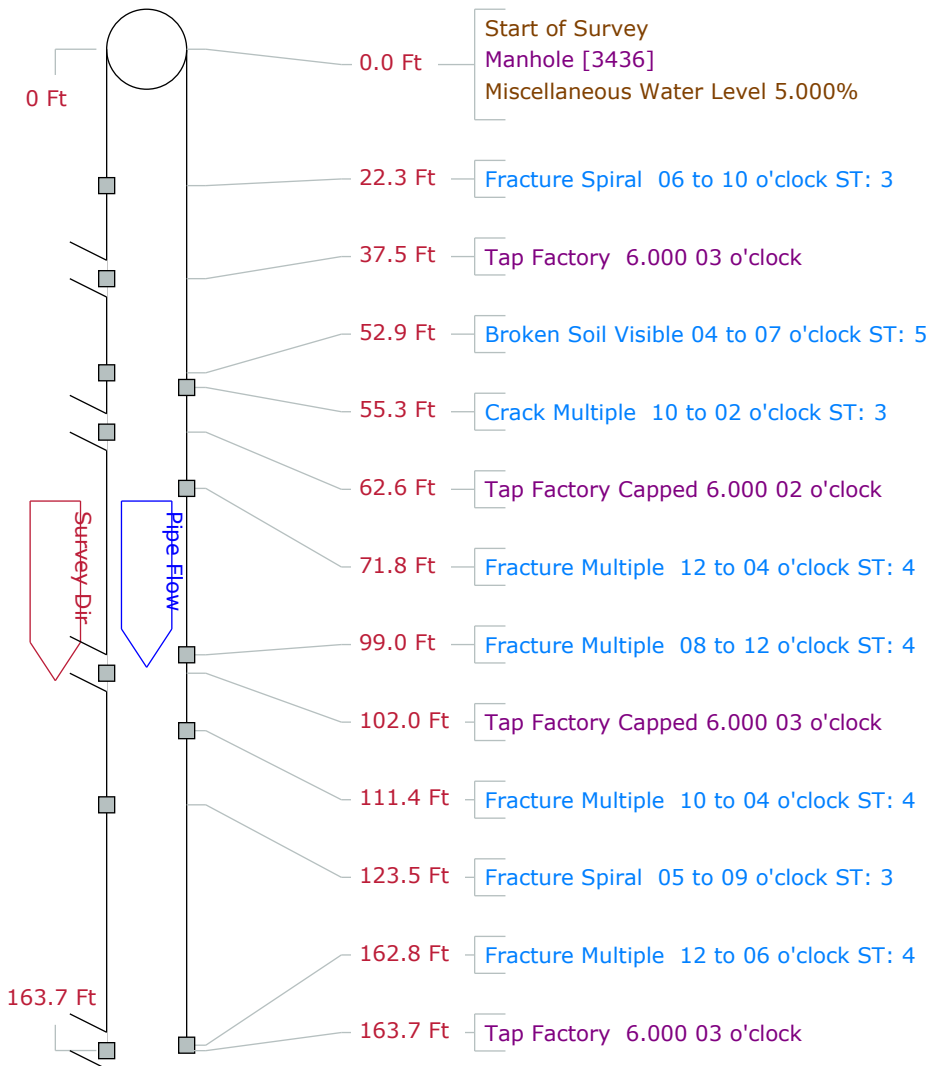
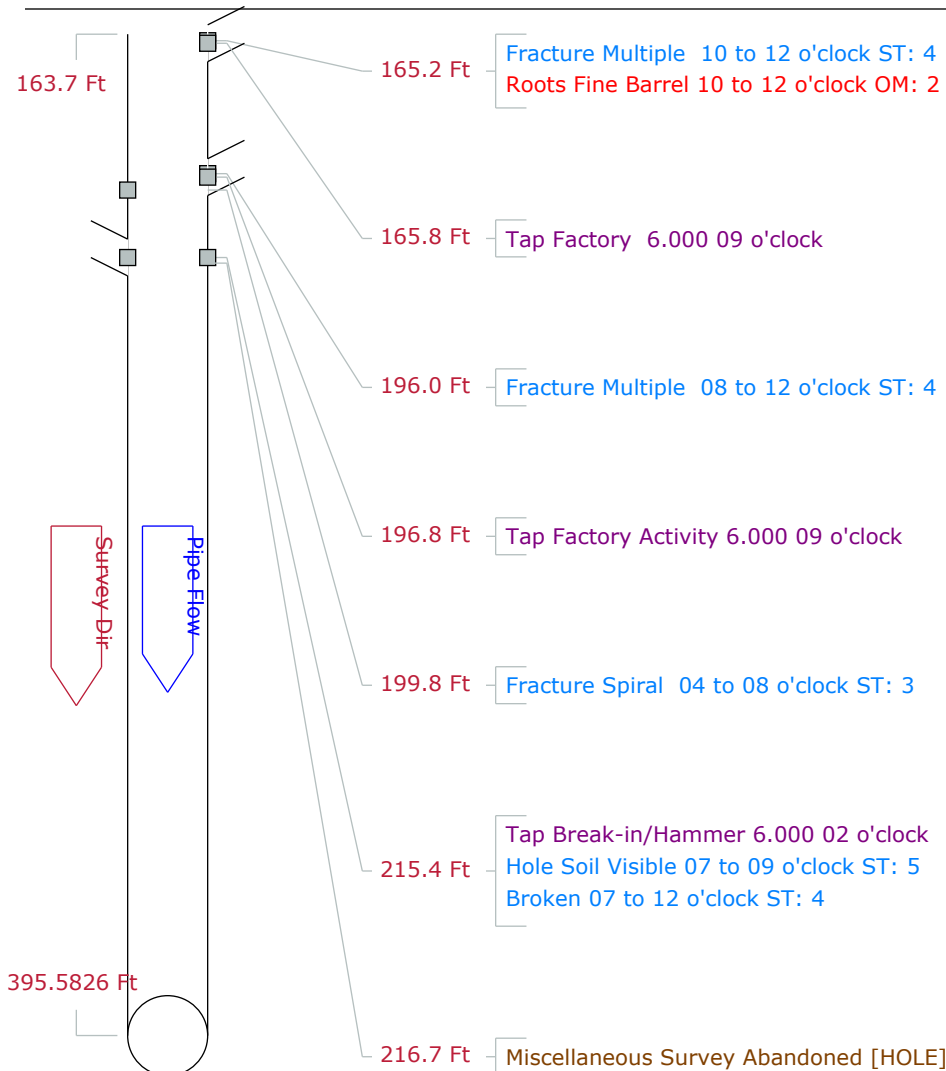
Tabular Report of PSR 3835
for Hillsdale

22.3			FS Fracture Spiral				J	06	10			
37.5			TF Tap Factory	6.000				03				
52.9			BSV Broken Soil Visible				J	04	07			
55.3			CM Crack Multiple				J	10	02

62.6			TFC Tap Factory Capped	6.000				02				
71.8			FM Fracture Multiple				J	12	04			
99.0			FM Fracture Multiple				J	08	12			
102.0			TFC Tap Factory Capped	6.000				03

111.4			FM Fracture Multiple				J	10	04			
123.5			FS Fracture Spiral				J	05	09			
162.8			FM Fracture Multiple				J	12	06			
163.7			TF Tap Factory	6.000				03

165.2			FM Fracture Multiple				J	10	12			
165.2			RFB Roots Fine Barrel					10	12			
165.8			TF Tap Factory	6.000				09				
196.0			FM Fracture Multiple				J	08	12

196.8			TFA Tap Factory Activity	6.000				09				
199.8			FS Fracture Spiral				J	04	08			
215.4			TB Tap Break-in/Hammer	6.000				02				
215.4			HSV Hole Soil Visible					07	09

Count	Video	CD	Code	Val1	Val2	%	Jnt	Fr	To	ImRef	Remarks
215.4			B Broken					07	12		
216.7			MSA Miscellaneous Survey Abandoned								HOLE

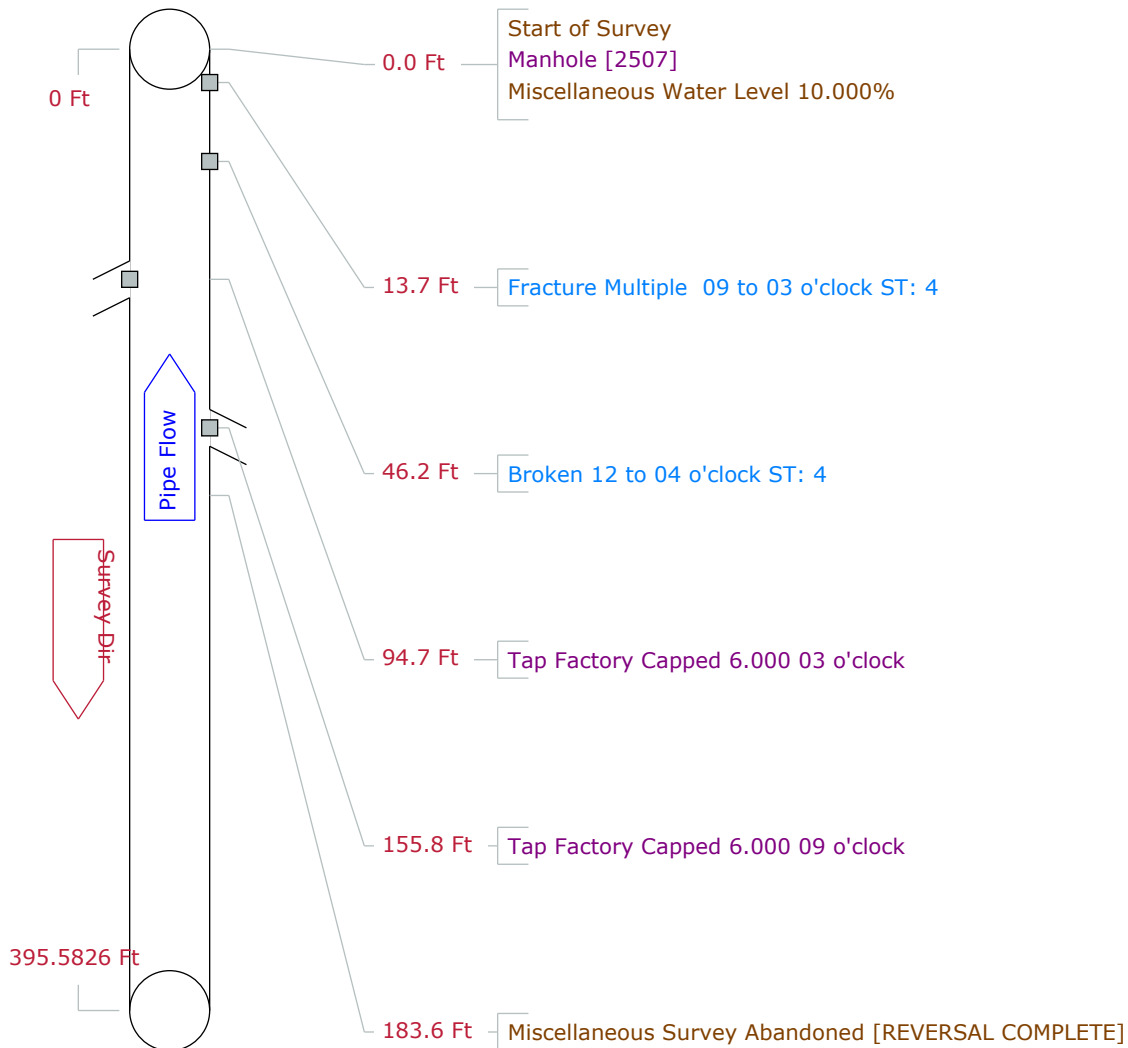
Tabular Report of PSR 3835
for Hillsdale

Count	Video	CD	Code	Val1	Val2	%	Jnt	Fr	To	Im	Ref	Remarks
0.0			ST Start of Survey									
0.0			AMH Manhole									2507
0.0			MWL Miscellaneous Water Level			10.000						
13.7			FM Fracture Multiple				J	09	03			
46.2			B Broken				J	12	04			
94.7			TFC Tap Factory Capped	6.000				03				
155.8			TFC Tap Factory Capped	6.000				09				
183.6			MSA Miscellaneous Survey Abandoned									REVERSAL COMPLETE

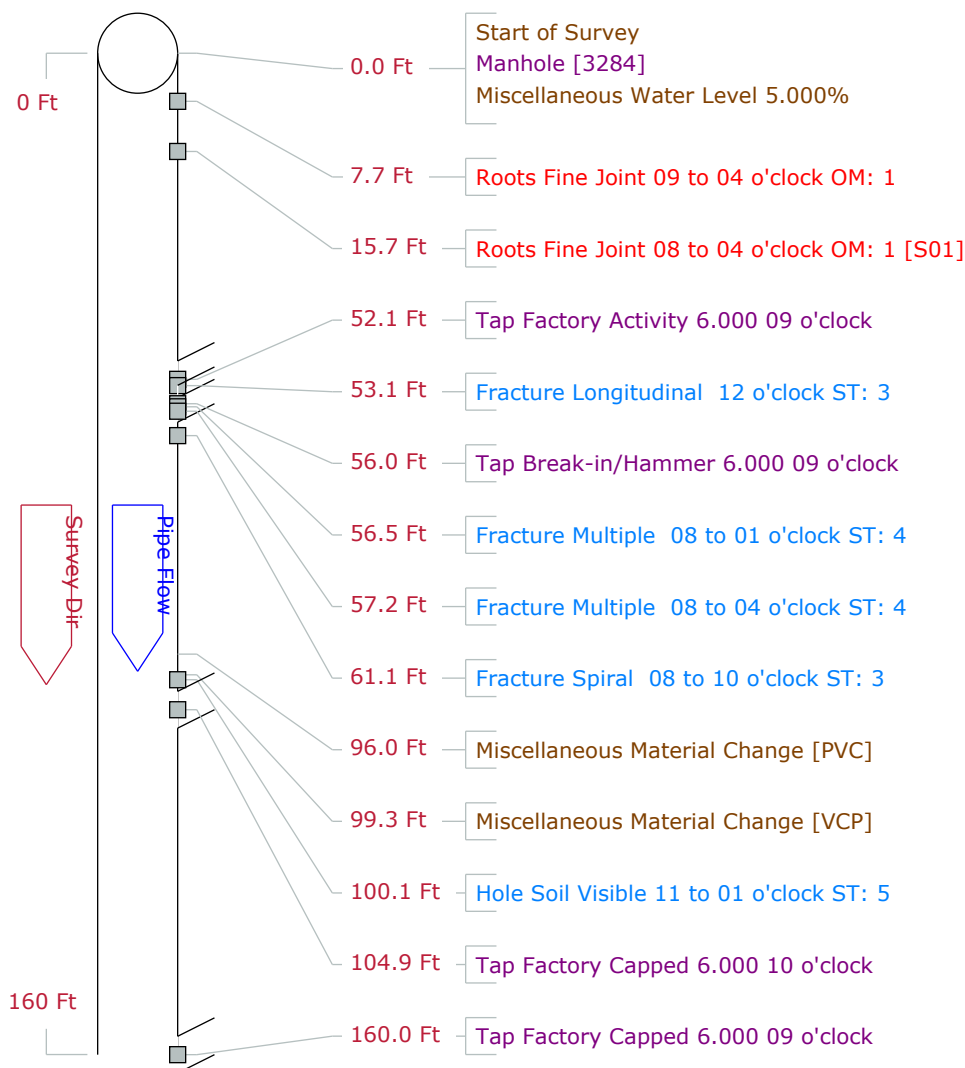
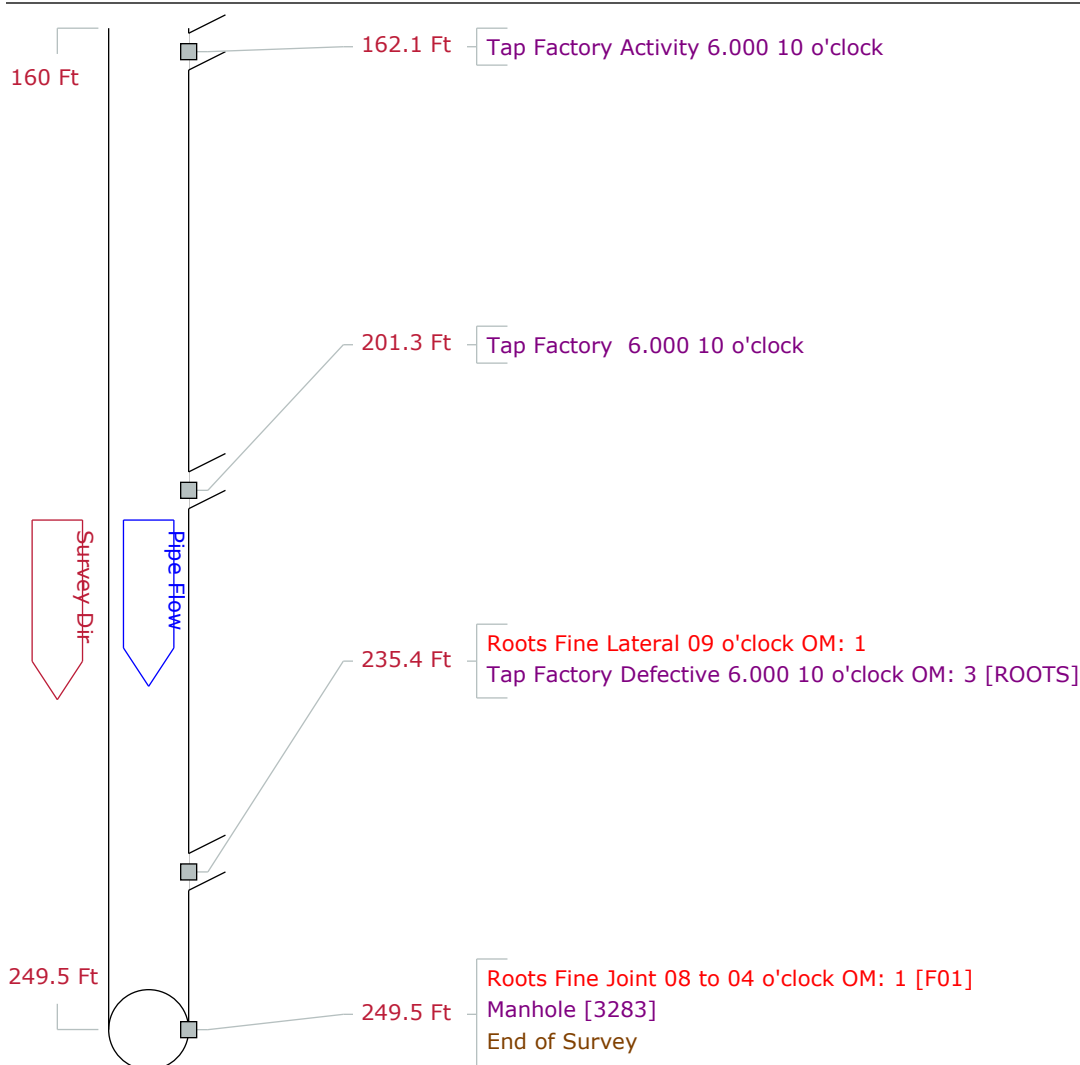
Tabular Report of PSR 4279
for Hillsdale

7.7			RFJ Roots Fine Joint				J	09	04			
15.7		S01	RFJ Roots Fine Joint				J	08	04			
52.1			TFA Tap Factory Activity	6.000				09				
53.1			FL Fracture Longitudinal				J	12

56.0			TB Tap Break-in/Hammer	6.000				09				
56.5			FM Fracture Multiple				J	08	01			
57.2			FM Fracture Multiple				J	08	04			
61.1			FS Fracture Spiral				J	08	10

235.4			TFD Tap Factory Defective	6.000				10				ROOTS
249.5		F01	RFJ Roots Fine Joint				J	08	04			
249.5			AMH Manhole									3283
249.5			FH End of Survey

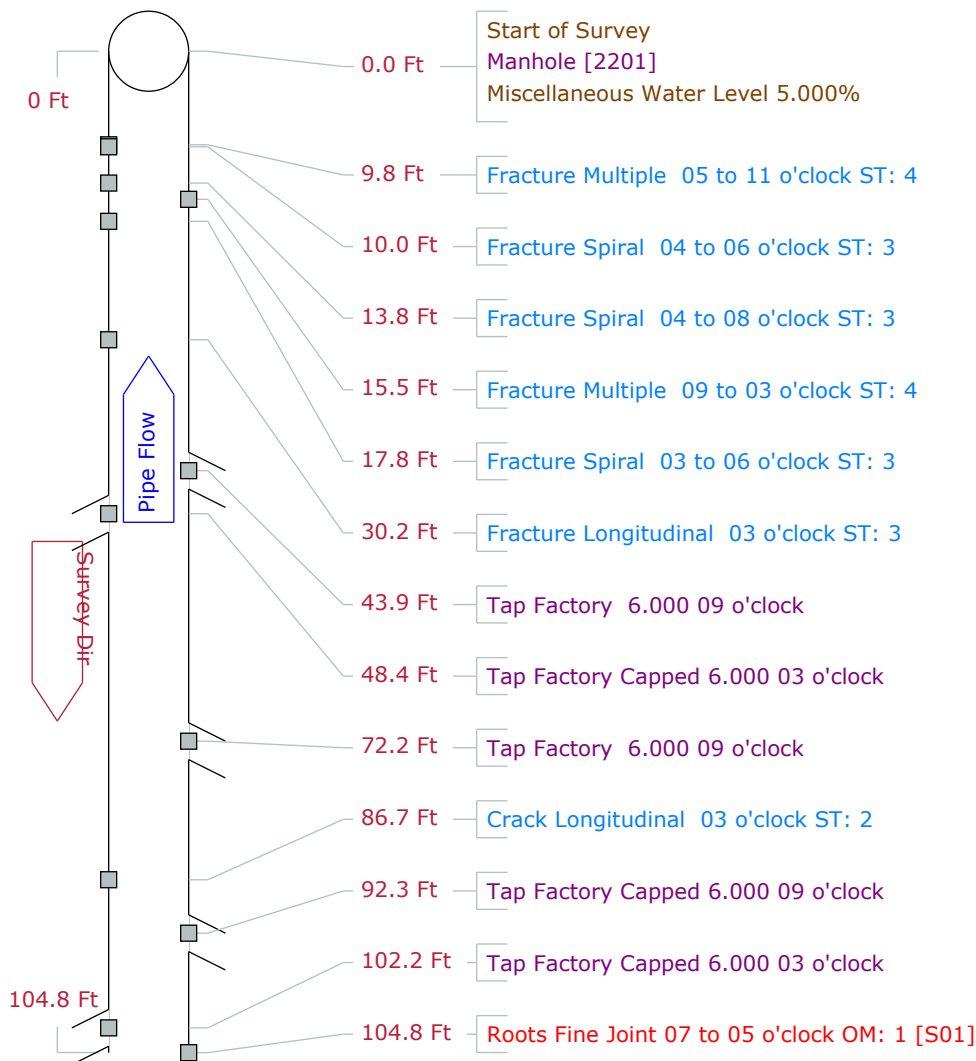
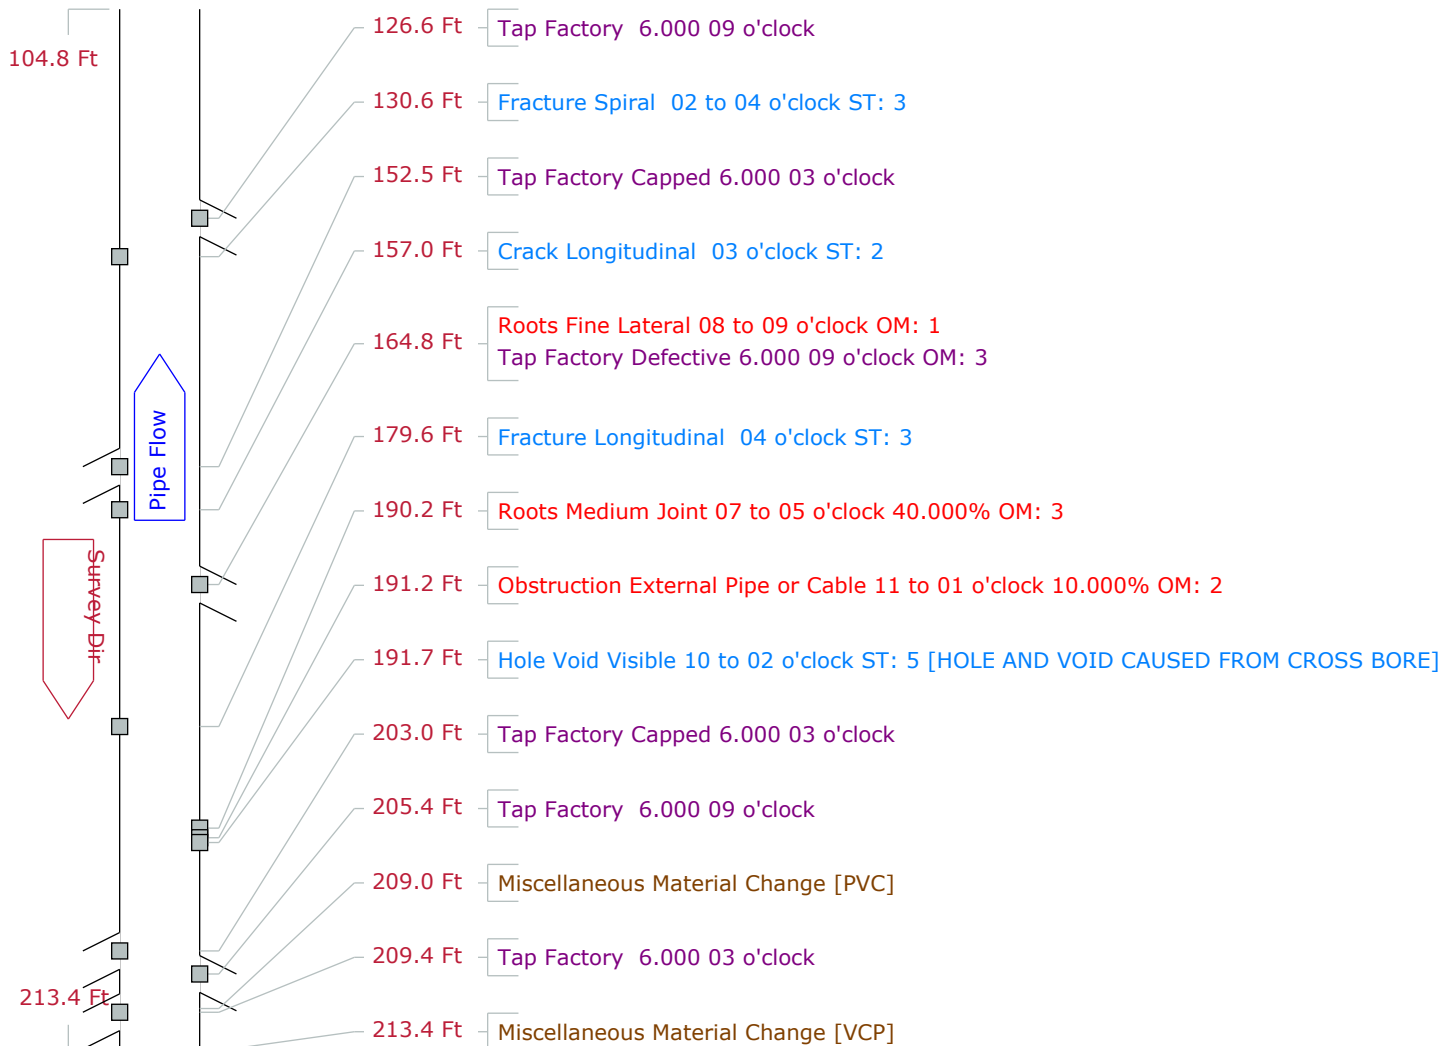
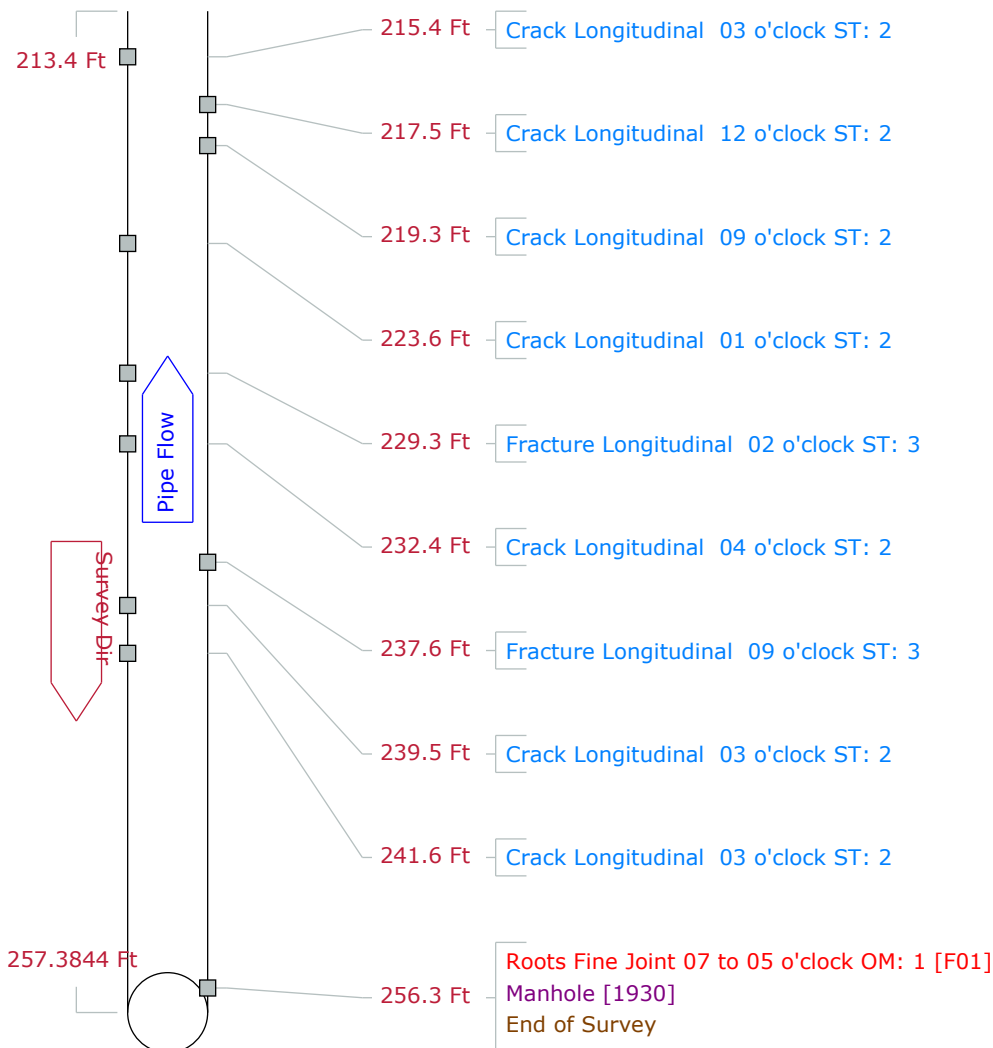
Tabular Report of PSR 4192
for Hillsdale

9.8			FM Fracture Multiple				J	05	11			
10.0			FS Fracture Spiral				J	04	06			
13.8			FS Fracture Spiral				J	04	08			
15.5			FM Fracture Multiple				J	09	03

17.8			FS Fracture Spiral				J	03	06			
30.2			FL Fracture Longitudinal				J	03				
43.9			TF Tap Factory	6.000				09				
48.4			TFC Tap Factory Capped	6.000				03

72.2			TF Tap Factory	6.000				09				
86.7			CL Crack Longitudinal				J	03				
92.3			TFC Tap Factory Capped	6.000				09				
102.2			TFC Tap Factory Capped	6.000				03

104.8		S01	RFJ Roots Fine Joint				J	07	05			
126.6			TF Tap Factory	6.000				09				
130.6			FS Fracture Spiral				J	02	04			
152.5			TFC Tap Factory Capped	6.000				03

157.0			CL Crack Longitudinal				J	03				
164.8			RFL Roots Fine Lateral					08	09			
164.8			TFD Tap Factory Defective	6.000				09				
179.6			FL Fracture Longitudinal				J	04

191.2			OBP	Obstruction External Pipe or Cable			10.000		11	01		
191.7			HVV	Hole Void Visible					10	02		HOLE AND VOID CAUSED FROM C
203.0			TFC	Tap Factory Capped	6.000				03

215.4			CL	Crack Longitudinal				J	03			
217.5			CL	Crack Longitudinal				J	12			
219.3			CL	Crack Longitudinal				J	09			
223.6			CL	Crack Longitudinal				J	01

229.3			FL	Fracture Longitudinal				J	02			
232.4			CL	Crack Longitudinal				J	04			
237.6			FL	Fracture Longitudinal				J	09			
239.5			CL	Crack Longitudinal				J	03

241.6			CL	Crack Longitudinal				J	03			
256.3		F01	RFJ	Roots Fine Joint				J	07	05		
256.3			AMH	Manhole								1930
256.3			FH	End of Survey

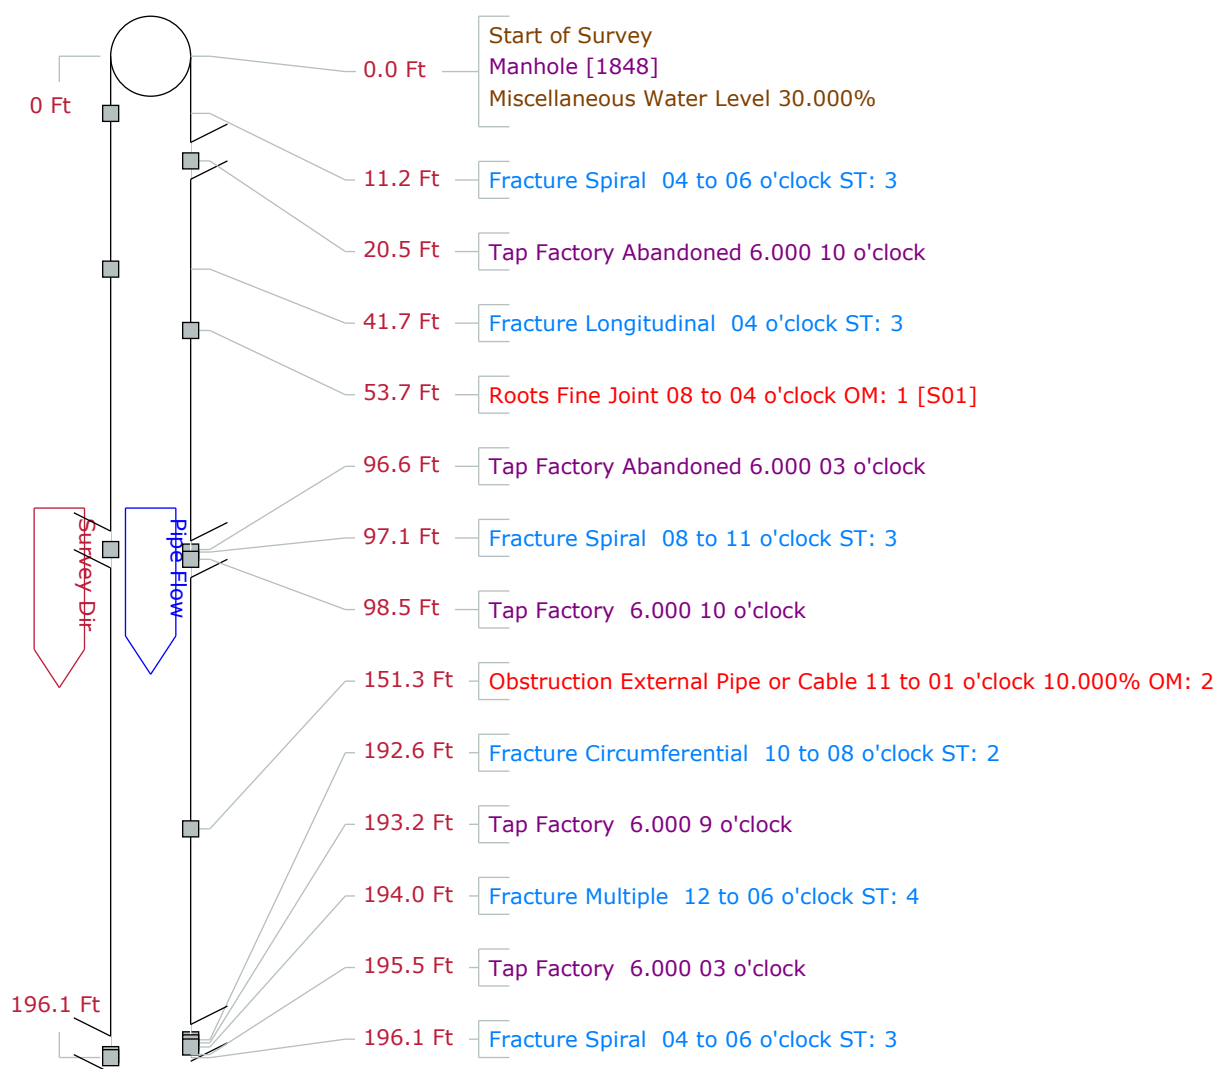
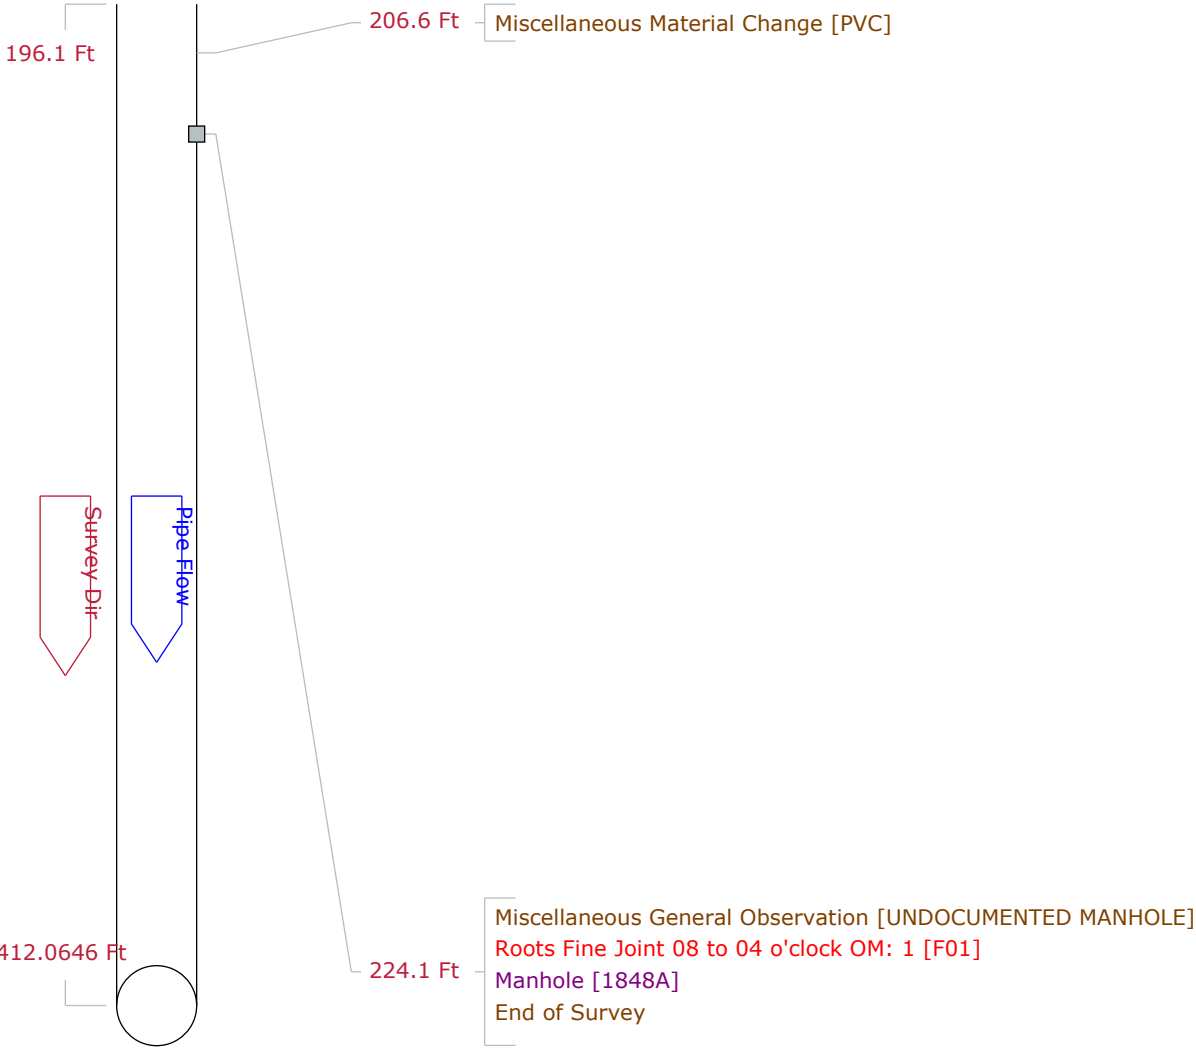
Tabular Report of PSR 4110
for Hillsdale

11.2			FS Fracture Spiral				J	04	06			
20.5			TFB Tap Factory Abandoned	6.000				10				
41.7			FL Fracture Longitudinal				J	04				
53.7		S01	RFJ Roots Fine Joint				J	08	04

96.6			TFB Tap Factory Abandoned	6.000				03				
97.1			FS Fracture Spiral				J	08	11			
98.5			TF Tap Factory	6.000				10				
151.3			OBP Obstruction External Pipe or Cable			10.000		11	01

192.6			FC Fracture Circumferential					10	08			
193.2			TF Tap Factory	6.000				9				
194.0			FM Fracture Multiple				J	12	06			
195.5			TF Tap Factory	6.000				03

196.1			FS Fracture Spiral				J	04	06			
206.6			MMC Miscellaneous Material Change									PVC
224.1			MGO Miscellaneous General Observation									UNDOCUMENTED MANHOLE

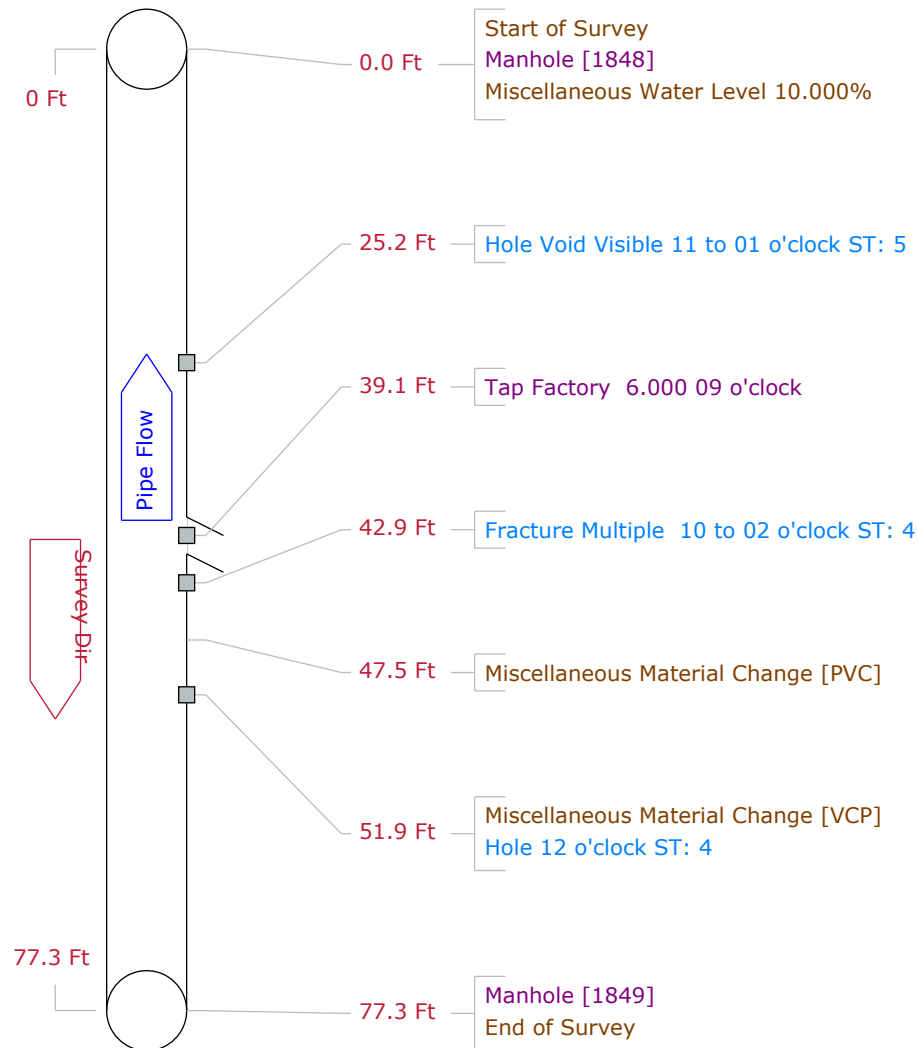
Tabular Report of PSR 4108

Count Video	CD Code	Val1	Val2	%	Jnt	Fr	To	ImRef	Remarks
0.0	ST	Start of Survey							
0.0	AMH	Manhole							1848
0.0	MWL	Miscellaneous Water Level		10.000					
25.2	HVV	Hole Void Visible			J	11	01		
39.1	TF	Tap Factory	6.000			09			
42.9	FM	Fracture Multiple			J	10	02		
47.5	MMC	Miscellaneous Material Change							PVC
51.9	MMC	Miscellaneous Material Change							VCP
51.9	H	Hole				12			
77.3	AMH	Manhole							1849
77.3	FH	End of Survey
